Supporting Documentation Audlem St James – Bells

Refurbishment of Bells at St James The Great Audlem

STRUCTURAL REPORT

Client: St James the Great, Audlem, PCC

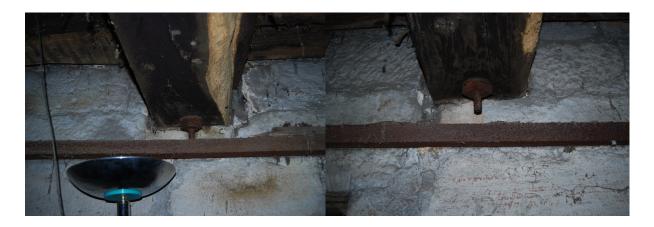
- 2.03 In general, the bell frame members are adequate and in fair condition, consistent with their age. The top sills have been cut out in places to allow the bells to swing freely and, although this has reduced the original cross section, there is no evidence of any significant structural distress, nor any significant differential movement at the frame joints.

North West

North East

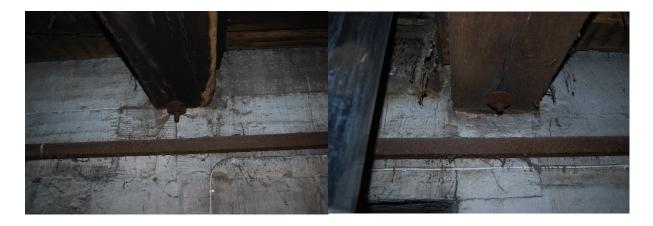
South East

South West

2.04 The ends of the bell frame support beams were observed from below with all six bells being rung full circle. Minor differential vertical and horizontal movement was noted at all four bearings in the walls, indicating that there is not full contact between the soffits of the beams and the masonry which supports them. Close to the bearing points, the beams have been bolted to the bottom sills of the bell frame. Just below the timber beams, horizontal ferrous metal tie bars have been installed close to all four internal elevations. The ends of these bars extend through the walls of the tower and are secured by pattress plates which are evident externally. In the case of the western beam at its northern end, the vertical bolt is too long and touches the tie bar below, causing some minor vertical deflection of the tie bar when the bells are rung full circle.

4.01 In view of the fact that the vertical through bolt connecting the western beam to the bell frame above at its northern end is touching the horizontal tie bar below, it is recommended that the end of the vertical bolt is cut short by approximately 15mm so that it is no longer in contact with the tie bar. This work should be carried out as soon as possible.

It is also recommended that, in the short term, steps are taken to ensure better bearing conditions where the beams are socketed into the walls. This could possibly be achieved by inserting thin slips of slate between the bottoms of the beams and the masonry below.

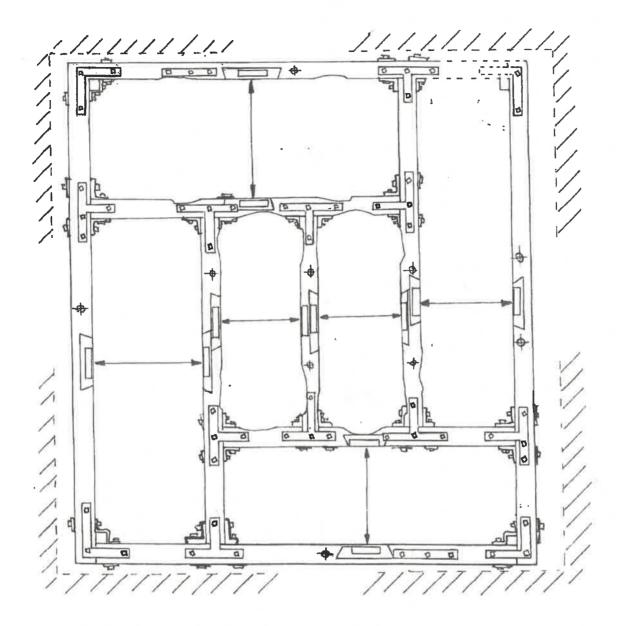
Figure 3. Plan of frame at frame-head level, north to the top, showing the relative position to the tower walls, drawn to a scale of 1:20, reduced to 70%. Positions of belfry windows are covered and hence not measured.

17.2.23 10NO. TIE BARS ADDED SHOWN AS \$

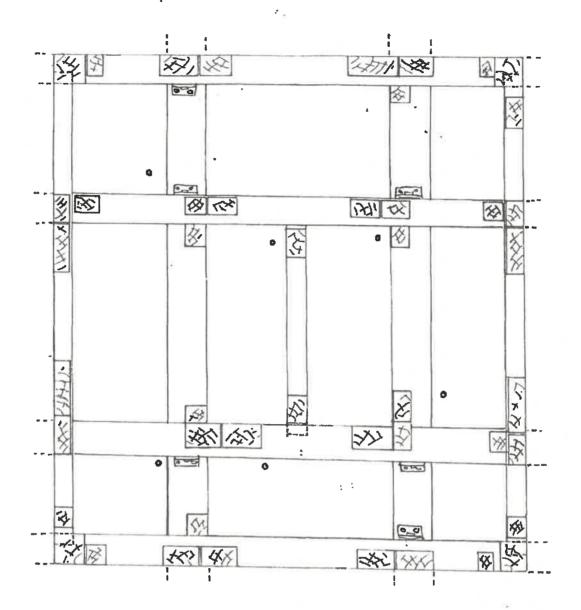
Plan of frame at sill level, showing roping positions of the six bells at the Figure 4. level of the pulleys, drawn to a scale of 1:20 and reduced to 70%.

28.11.22 6 NO. RSA BASE CLEATS TO FOUNDATION BEAM CONNECTIONS
