# Supporting Documentation

## Sutton St James – Window repairs

# Statement of Significance

Report on the Condition of the Glazing.

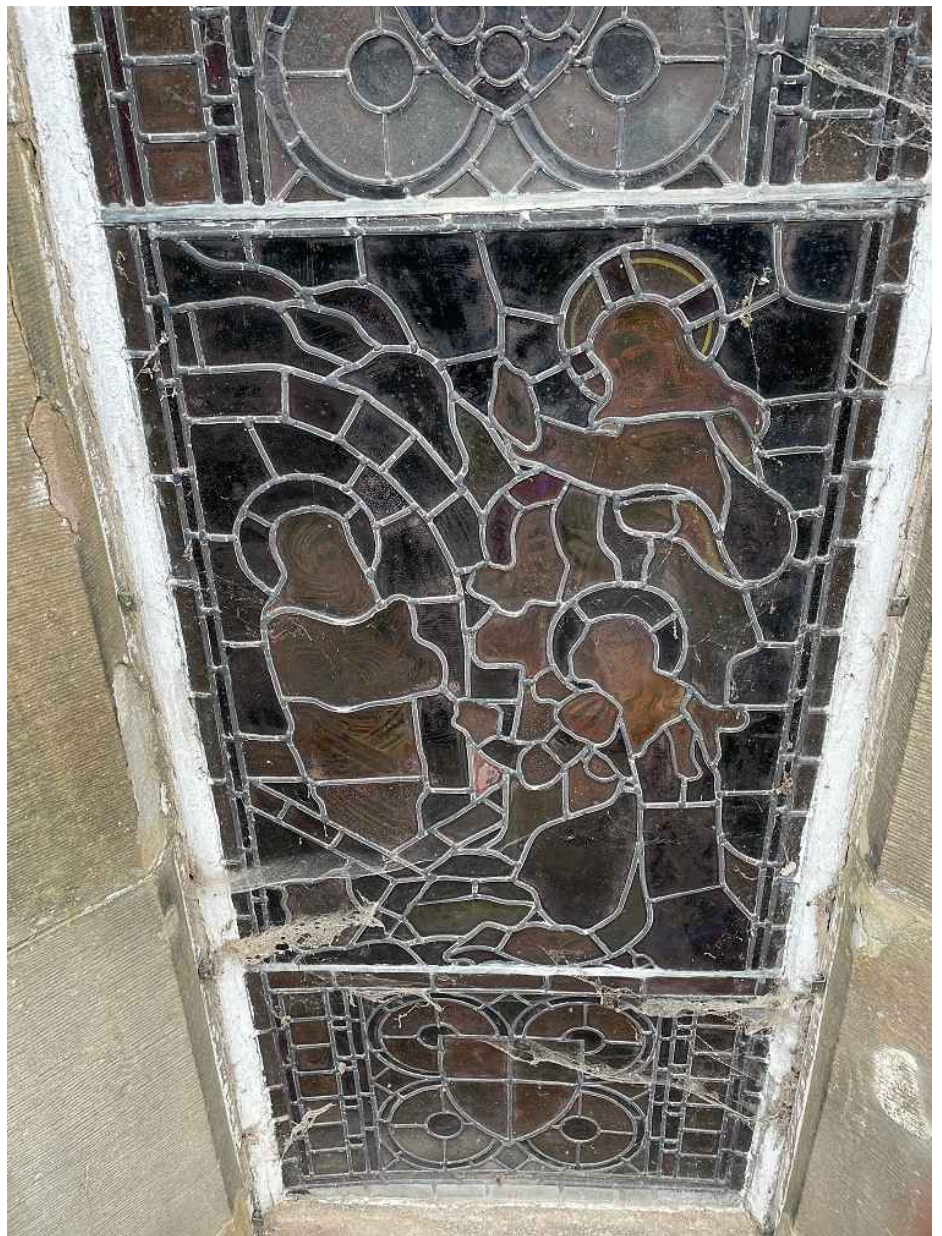
#### Sections 1 and 2:

The bottom pane, pane 1, has bulging/ bowing inwards along with some broken / cracked quarries. If left untreated bowing will increase and create further fractures to original quarries. Distorted lead comes.

Pane 2 has fractures to lead comes at head.

Lower section of timber frame details cut and splice repair.

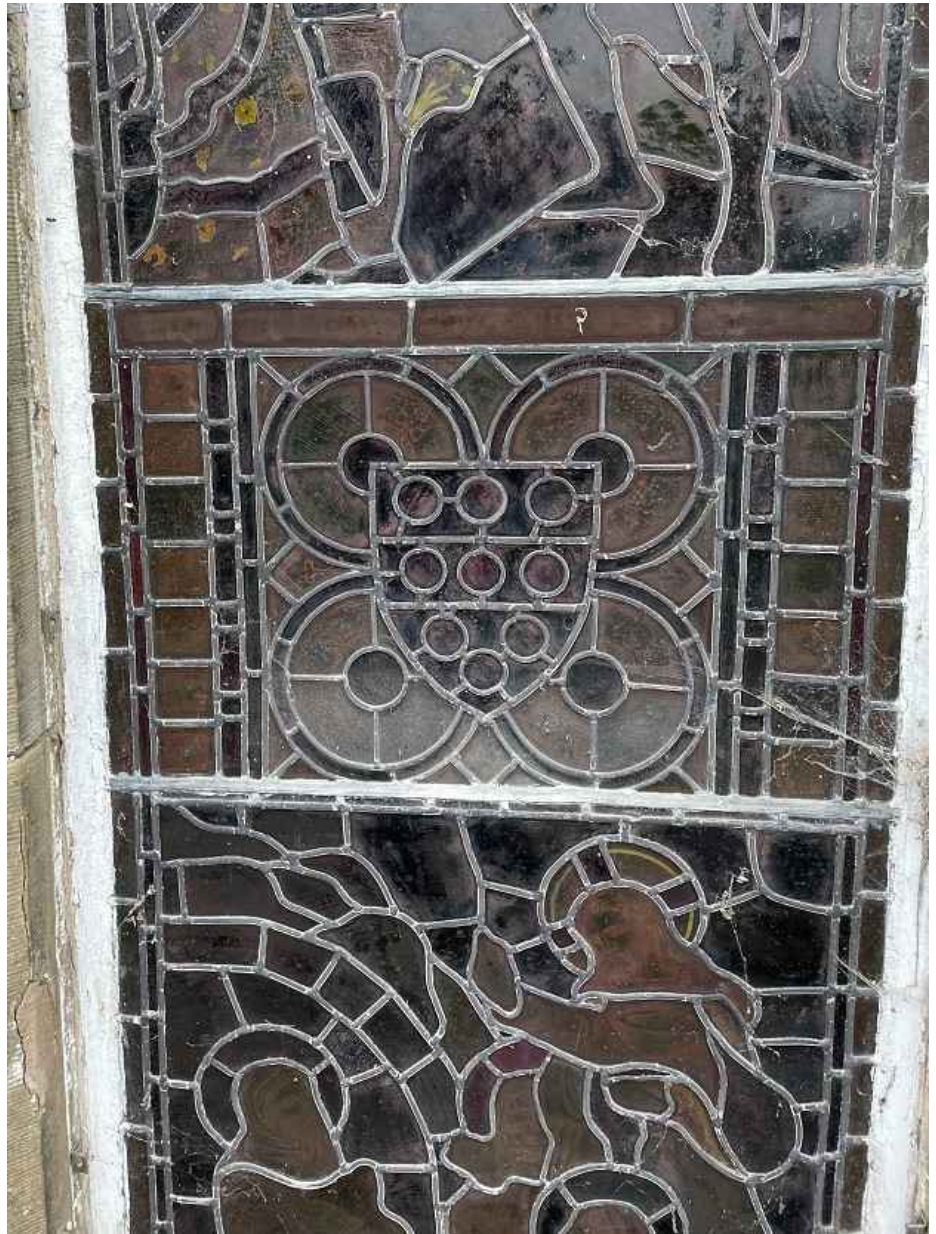
### **Section 3**

Central pane bows inwards with cracked quarries in particular to the outer edges of the design.

Loss of clarity to lettering to the inside of the window to the header of pane 3.

Lead comes are distorted.

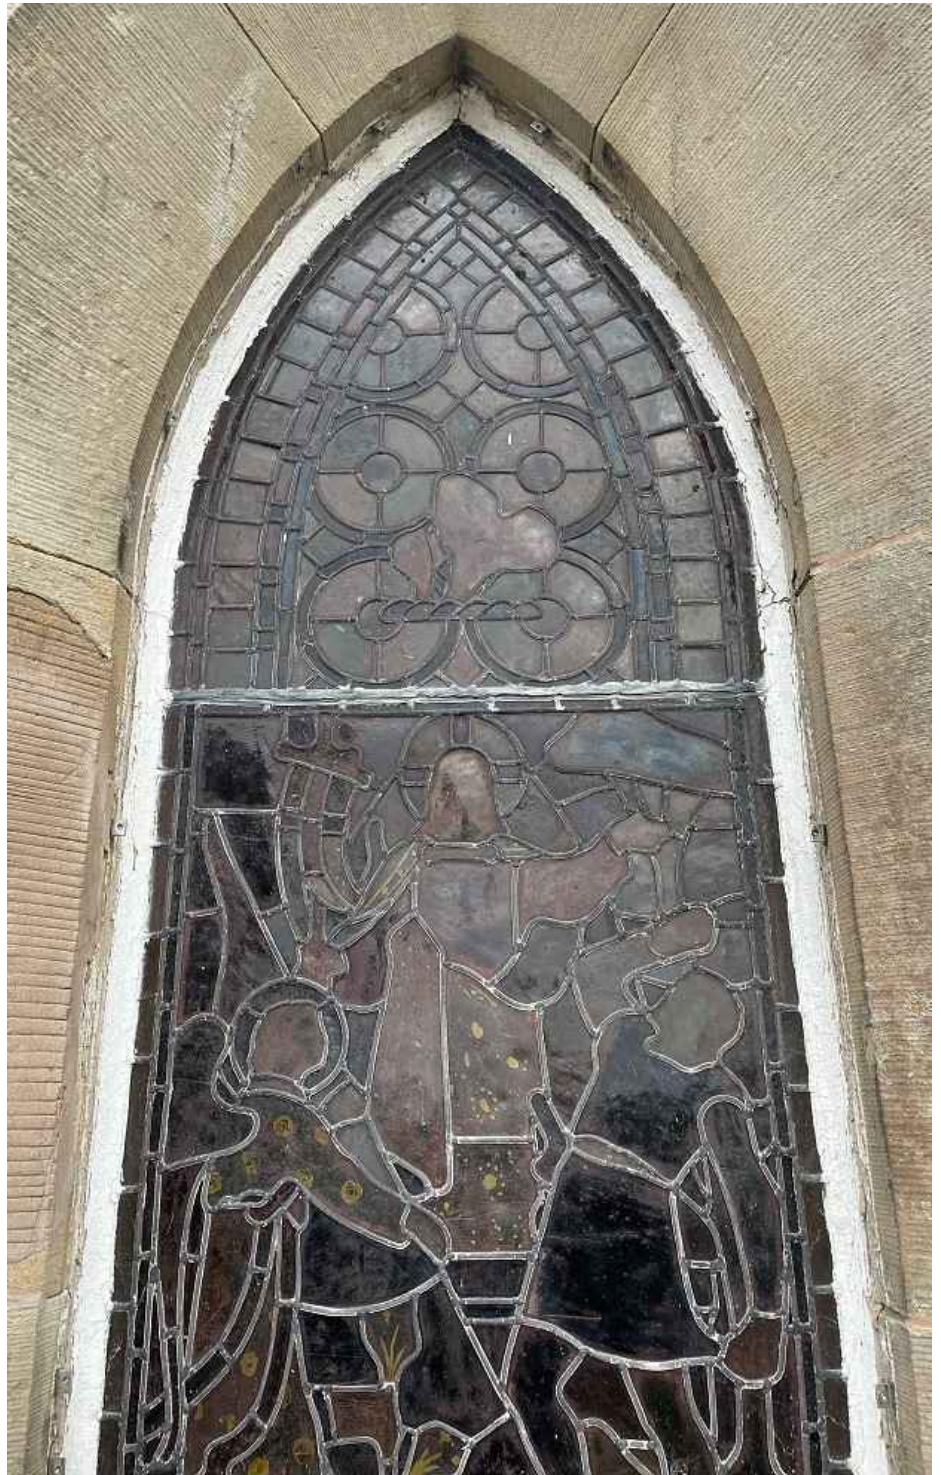
### Sections 4 and 5

Damage to quarries towards bottom of section 4. Cracked lead comes.

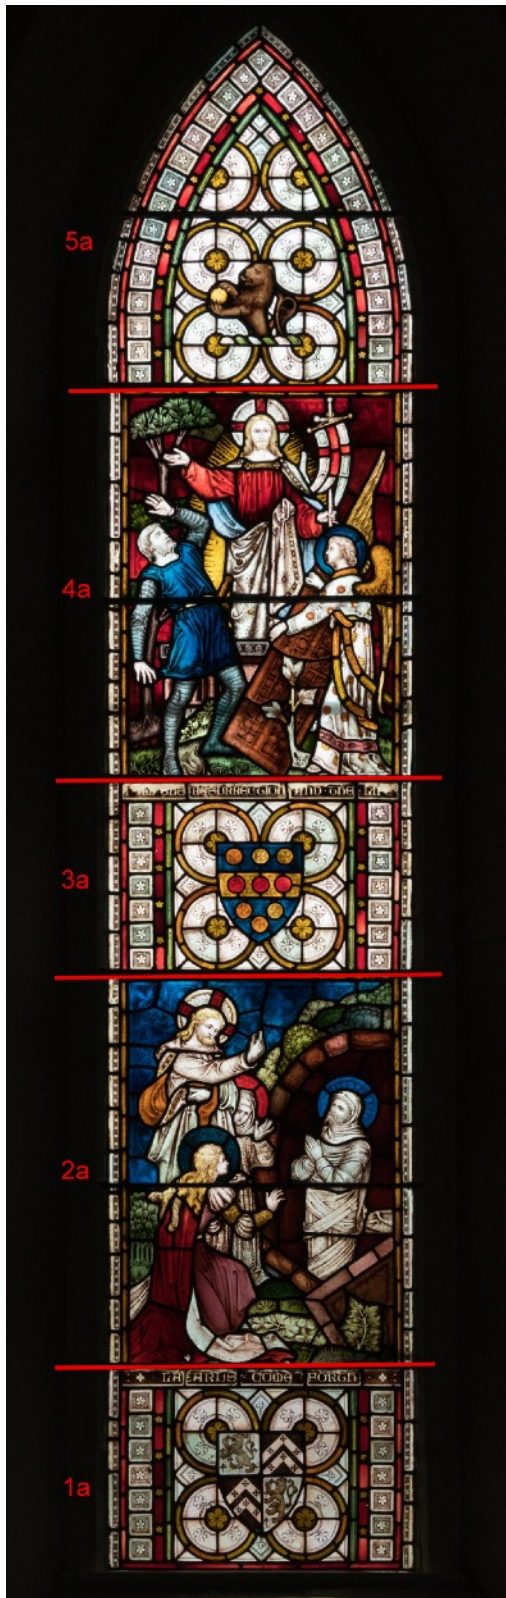
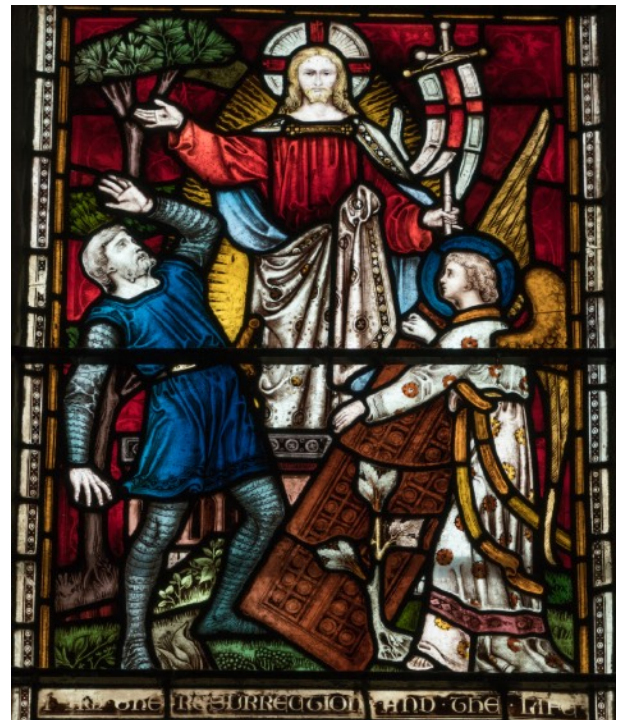
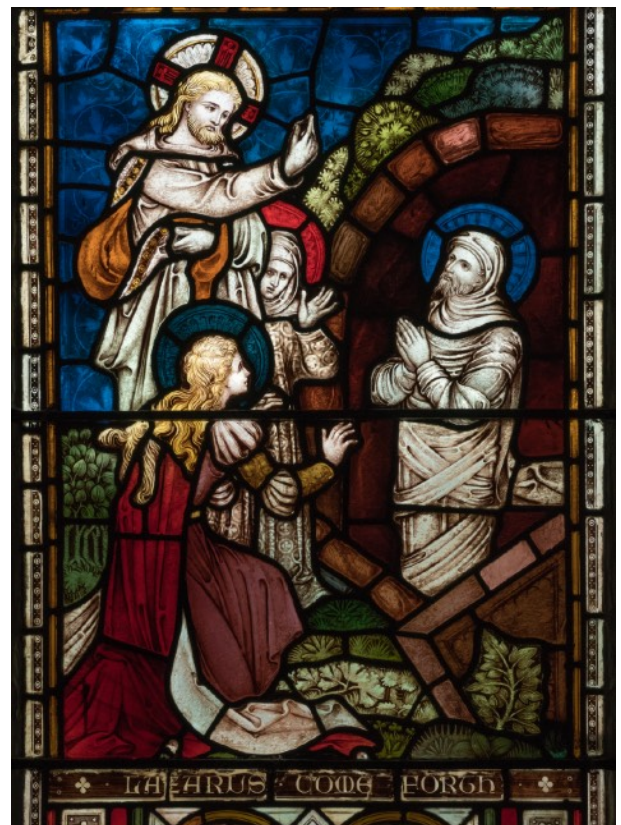
4.1 sVI. Single light (720mm x 3640mm) The Raising of Lazarus (panel 2a) and the Resurrection of Christ (panel 4a). Inscription date 1876. Attrib. Clayton and Bell.

The window is made up of 5 panels set into a painted timber sub-frame. Externally, the glazing is protected by polycarbonate sheeting.

The lead matrix in the lowest panel 1a has bowed up to 45mm from plumb which has caused some cracking to the glass due to the distortion of the lead matrix. The lead matrix is beginning to fail; a number of cracks can be seen at the solder joints particularly at the lower division and at the centre and base of Panel 1a.

There are eight failed or missing copper tie wires. There are 12 broken pieces of glass. Panel 1a is loose at the right hand (viewed from inside) perimeter.

The glass paint is generally very well adhered and in good condition. There is some sporadic paint-loss, notably to the two inscriptions below the main panels, this can probably be attributed to the poor firing of the glass paint in combination with the leaking of the horizontal panel division joint above each inscription.

The timber frame has been repaired in the past, the jambs having spliced repairs at the base. It appears that there is no wooden cill. All the other timber windows in the nave have a cill of approximately 100mm in height. In sVI, the stained glass appears to be sitting on the masonry cill, which may have contributed to the bowing of the panel at the base.

It is recommended that the lead matrix is replaced and that the stained glass is re-installed with additional support bars.

**6.5. Ferramenta.** The wrought iron bars are adequate in strength however the glazing has bowed due to inadequate frequency of bars. It is proposed that an additional 5no. bars are introduced to provide sufficient support to the new lead matrix.

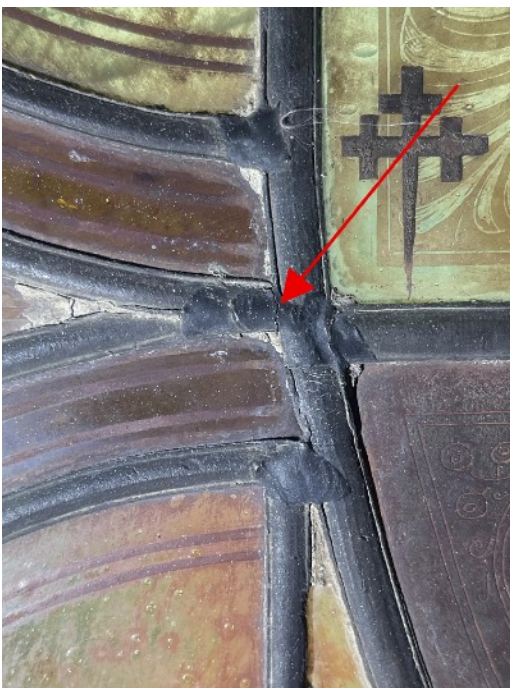
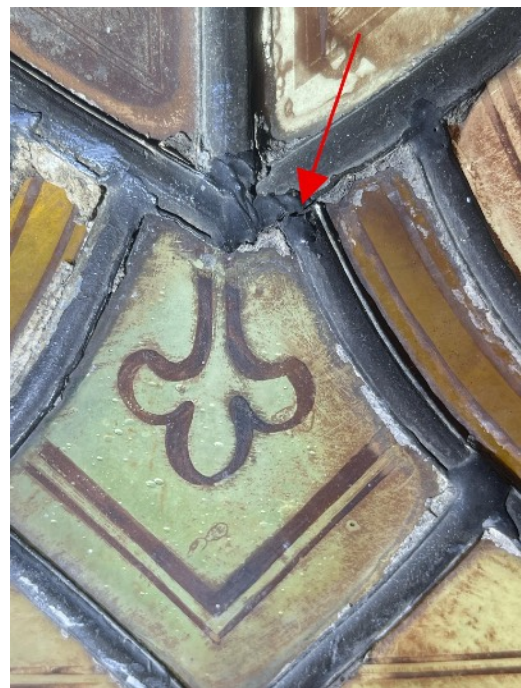
**sVI. Panel 1a. Detail.** The lead matrix has deteriorated, cracks can be observed at or near the solder joints.

**6.3. Replacement of the lead matrix.** Wax rubbings to be made of the panels prior to dismantling. Replacement lead comes to be of the same profile, weight and style as those existing.

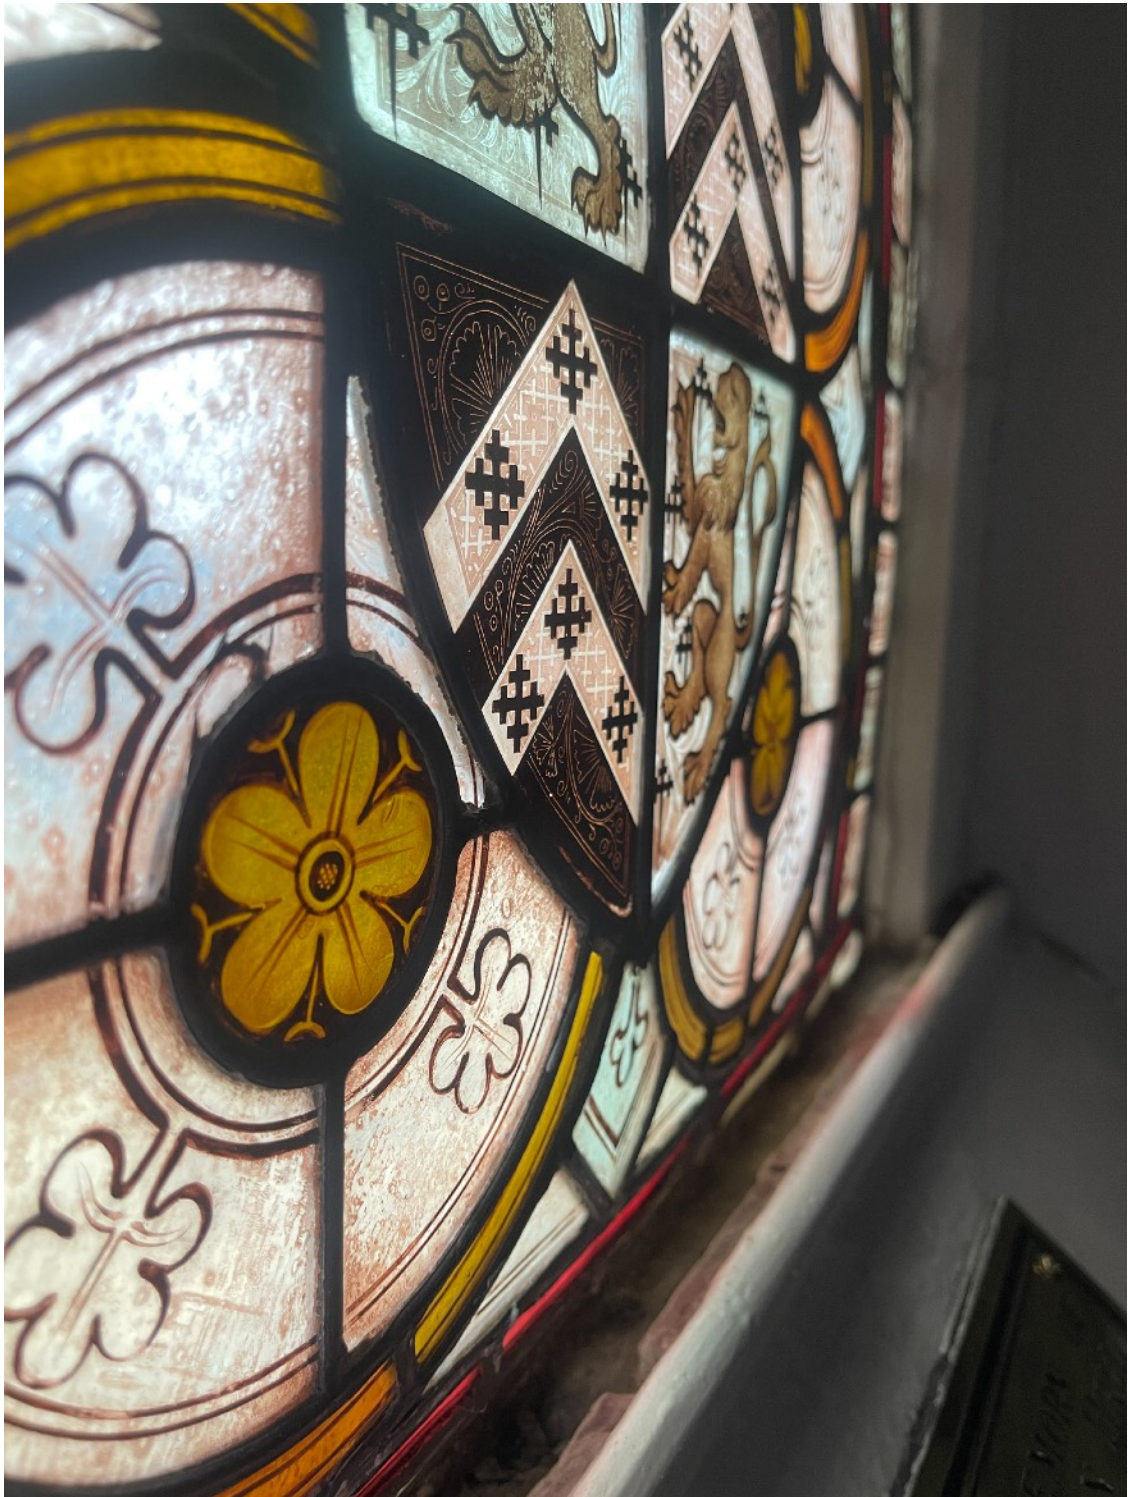
**sVI. Detail.** Panel 1a has bowed inwards up to 45mm from its original position.

**5.2.** Panels may have bulged as a result of their design, being leaded or installed ‘too tight’, or where there is an inadequate support system, i.e. where tie-bars are placed too far apart allowing leading to be affected by thermal expansion and the forces of gravity. Whilst the lead matrix of a stained glass window does have a limited life, replacing it should be considered carefully. The lead matrix is part of the original artwork and as such should be conserved if possible. The process of re-leading can cause damage to the glass. It is important that the support systems of tie-bars and soldered copper ties are functional in order to restrict the movement of the panel.

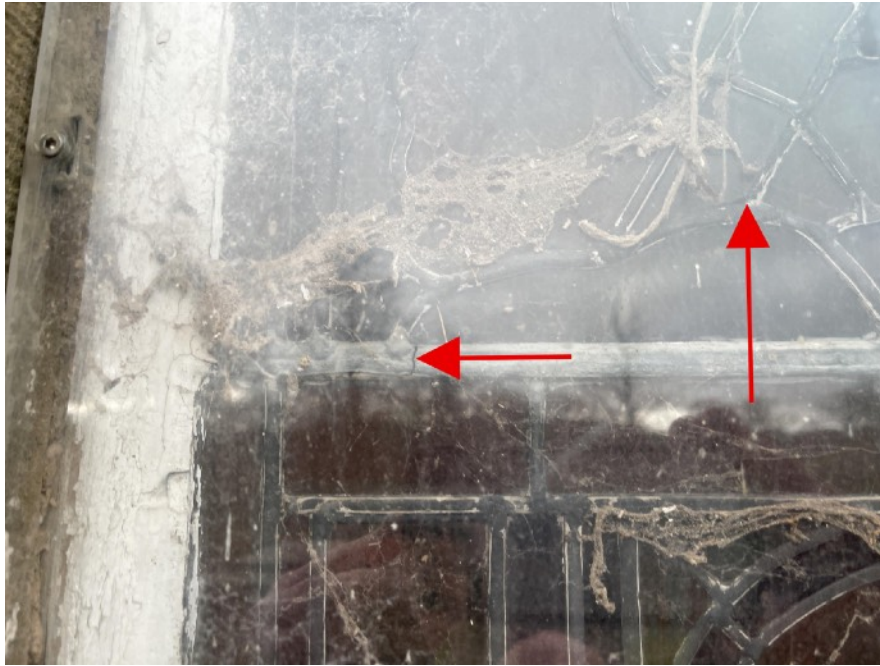
**sIV. Panel 2a. Detail.** The horizontal division lead is fractured. Glass is protruding from the lead matrix.

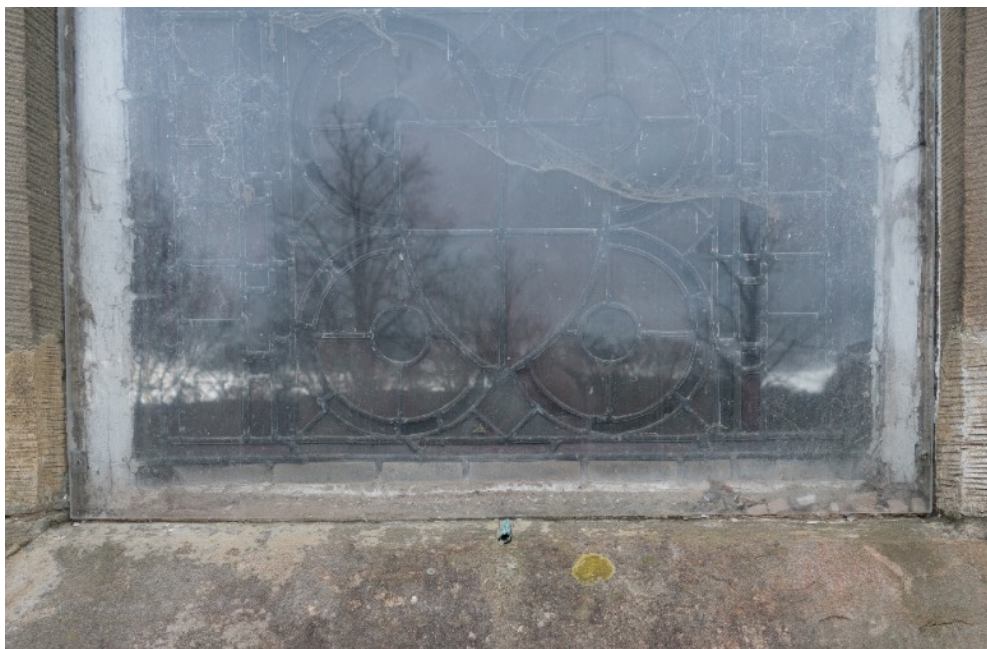
**sIV. Panel 1a. Detail.** The timber jambs have been repaired at the base. There appears to be no timber cill.
