Altrincham St George – Window repairs

Repair of two Stained glass Windows damaged by vandalism

INITIAL OVERVIEW

ALTRINCHAM ST. GEORGE; Schedule of Work and Specification

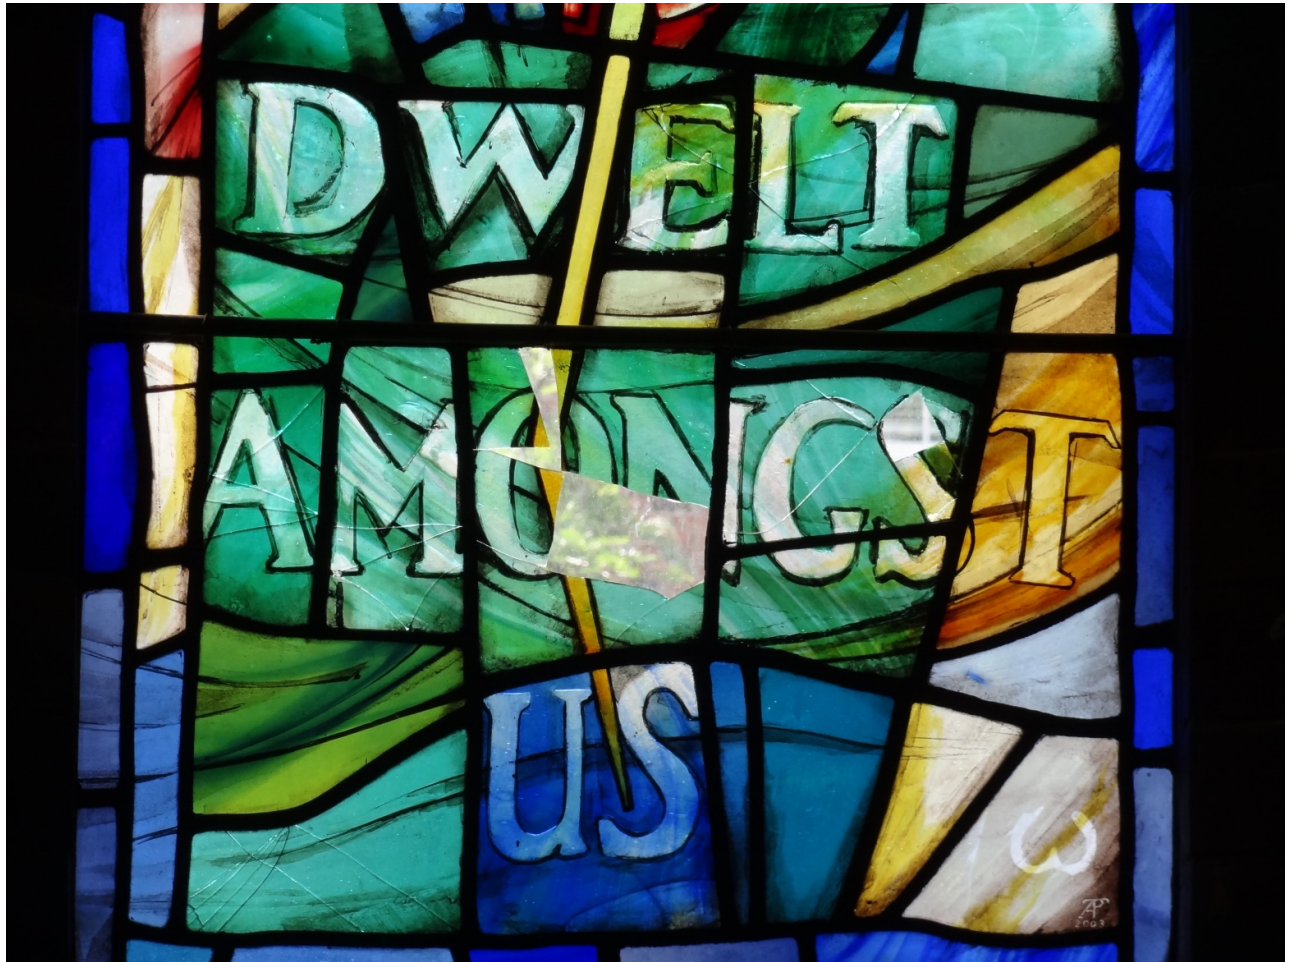
This window was given in memory of a Parishioner, and installed in 2003. Andrew Taylor was the stained-glass artist. Only one of the two lancets is damaged. The force of the blow against the polycarbonate protection meant that the lower section is damaged, as shown in the photos.

Damaged bottom Section of Lancel

To carefully remove the badly damaged bottom section only of the stained glass window, then temporary glaze the opening with timber boarding.

Bringing the stained glass section to our studio for restoration work as found necessary, comprising of taking detailed rubbings of the damaged section, setting out working drawings, carefully dismantling the damaged section noting the position of each piece of stained glass, then clean each piece using soft brushes and a mild solution.

Re-making the full section with new lead came sections matching the existing as near as possible, re-using as much of the existing glass as possible, replacing all damaged pieces of stained glass with new, each hand painted then fired on antique glass to match the existing as near as possible.

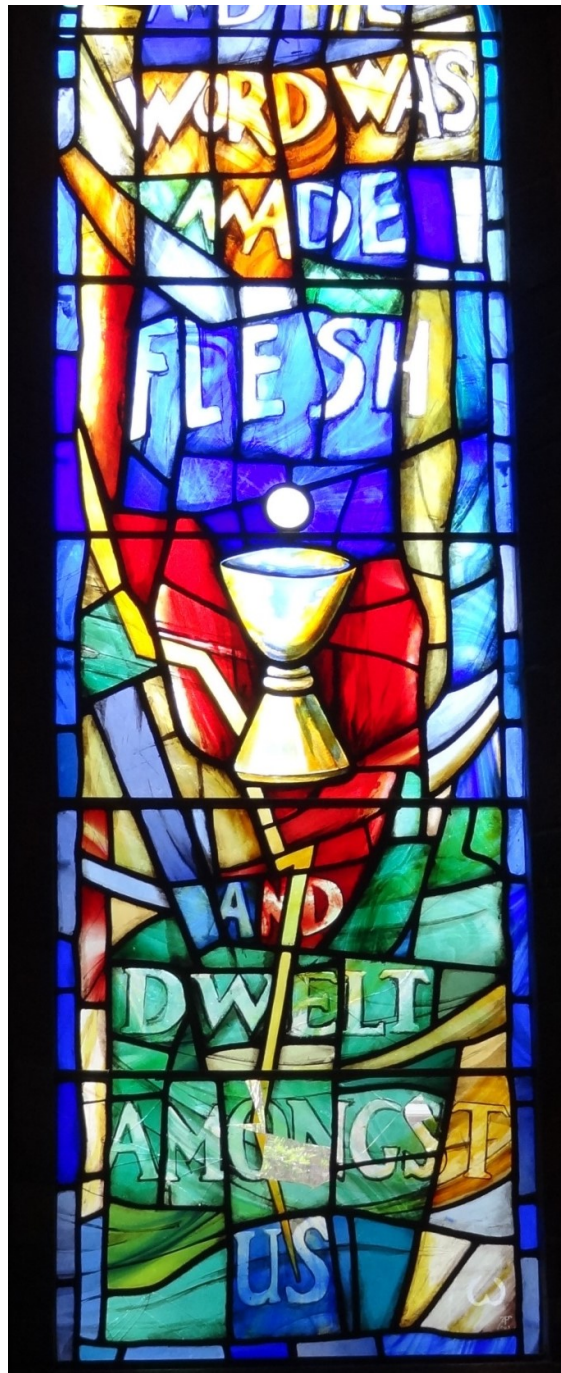
Full Lancet

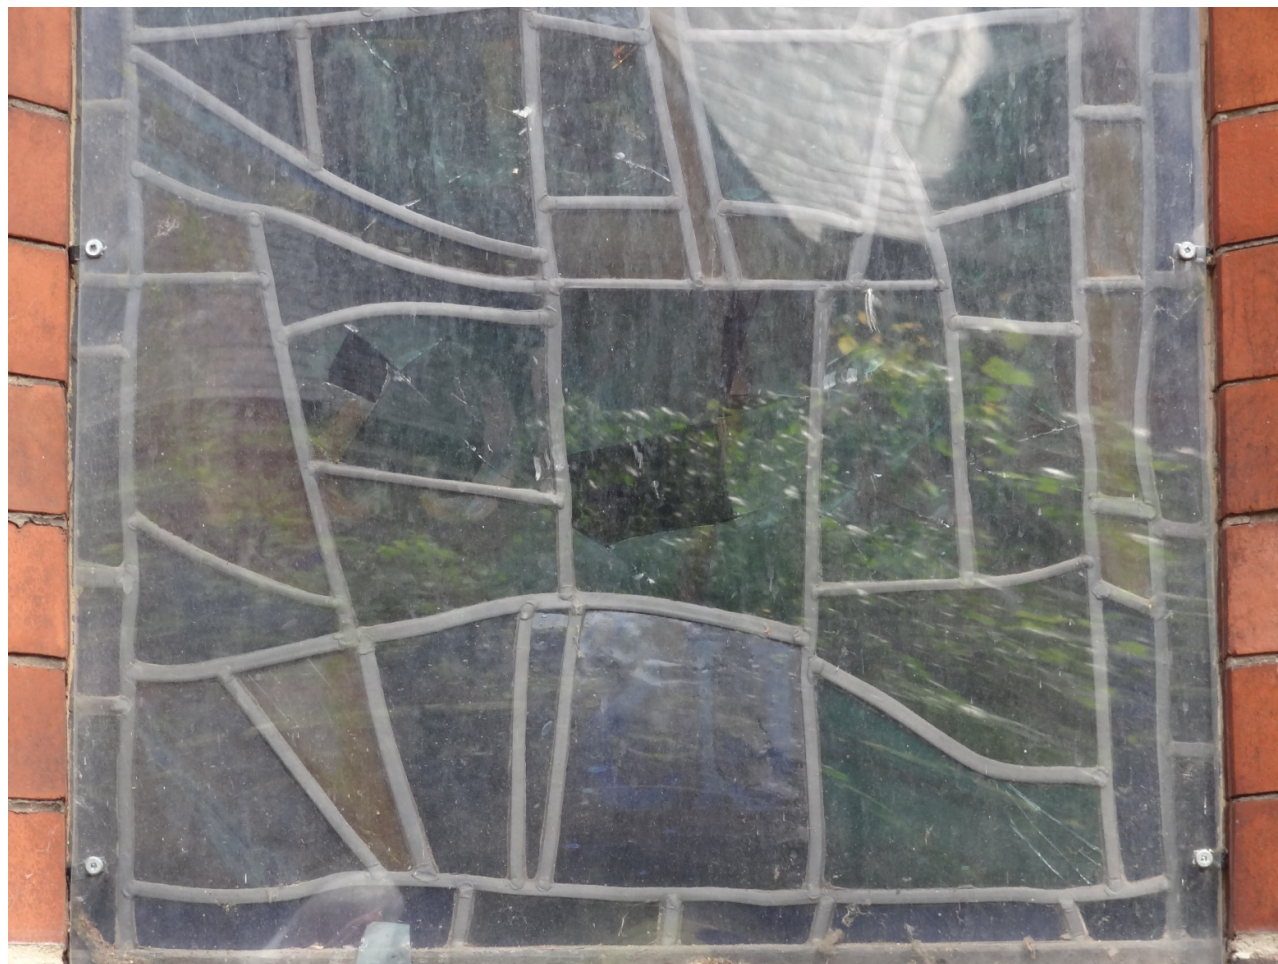
View from outside

All of the south side protective glazing is 4mm polycarbonate which is not a standard thickness to protect stained glass, But all of the windows have ferramenta bars on the outside which is adequate with 4mm polcarbonate to protect the windows, However the damaged stained glass window and the more modern to the others has no ferramenta bars on the outside with only 4mm polycarbonate protecting the window it hasn't much resistance to vanalisum being so flimsy. If 6mm polycarbonate was fitted with more clips it would'nt stop damaged caused by the concrete slab used to vandalise the window but it would considerably reduce damage to the window.

To replace two lancet stained glass windows from 4mm to using 6mm uv protected polycarbonate with more none ferrous clips fitted to the stonework.

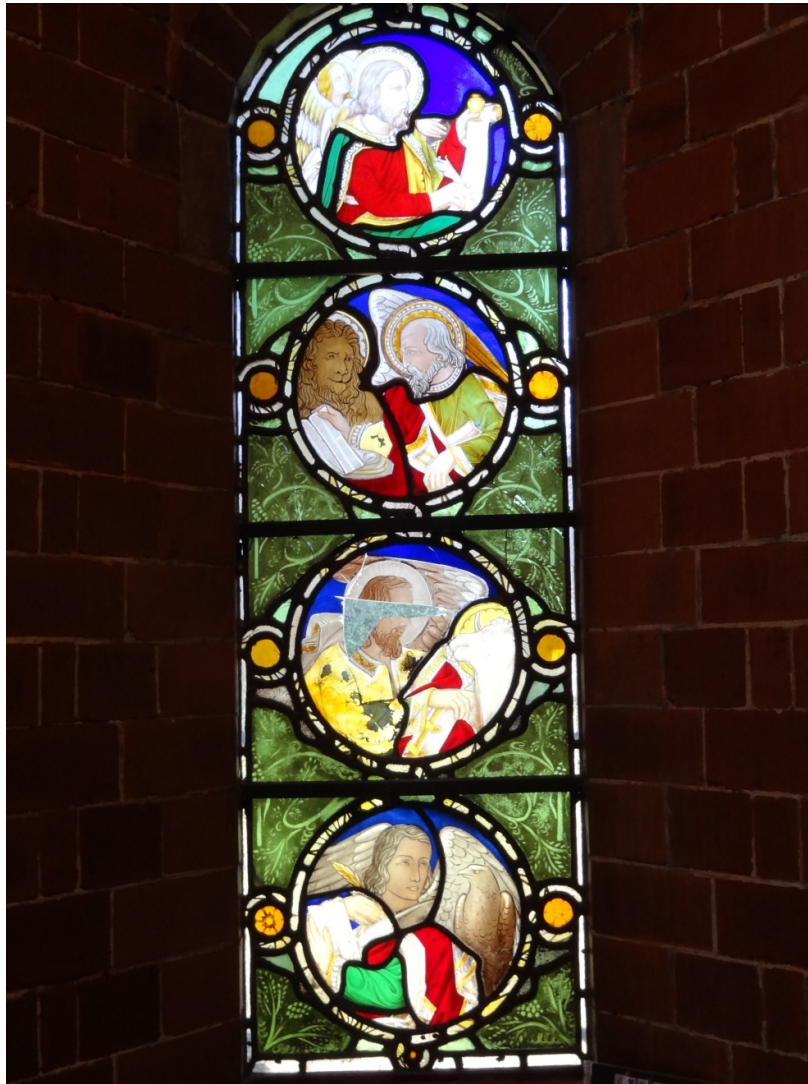
Central Porch Window - Full Lancet

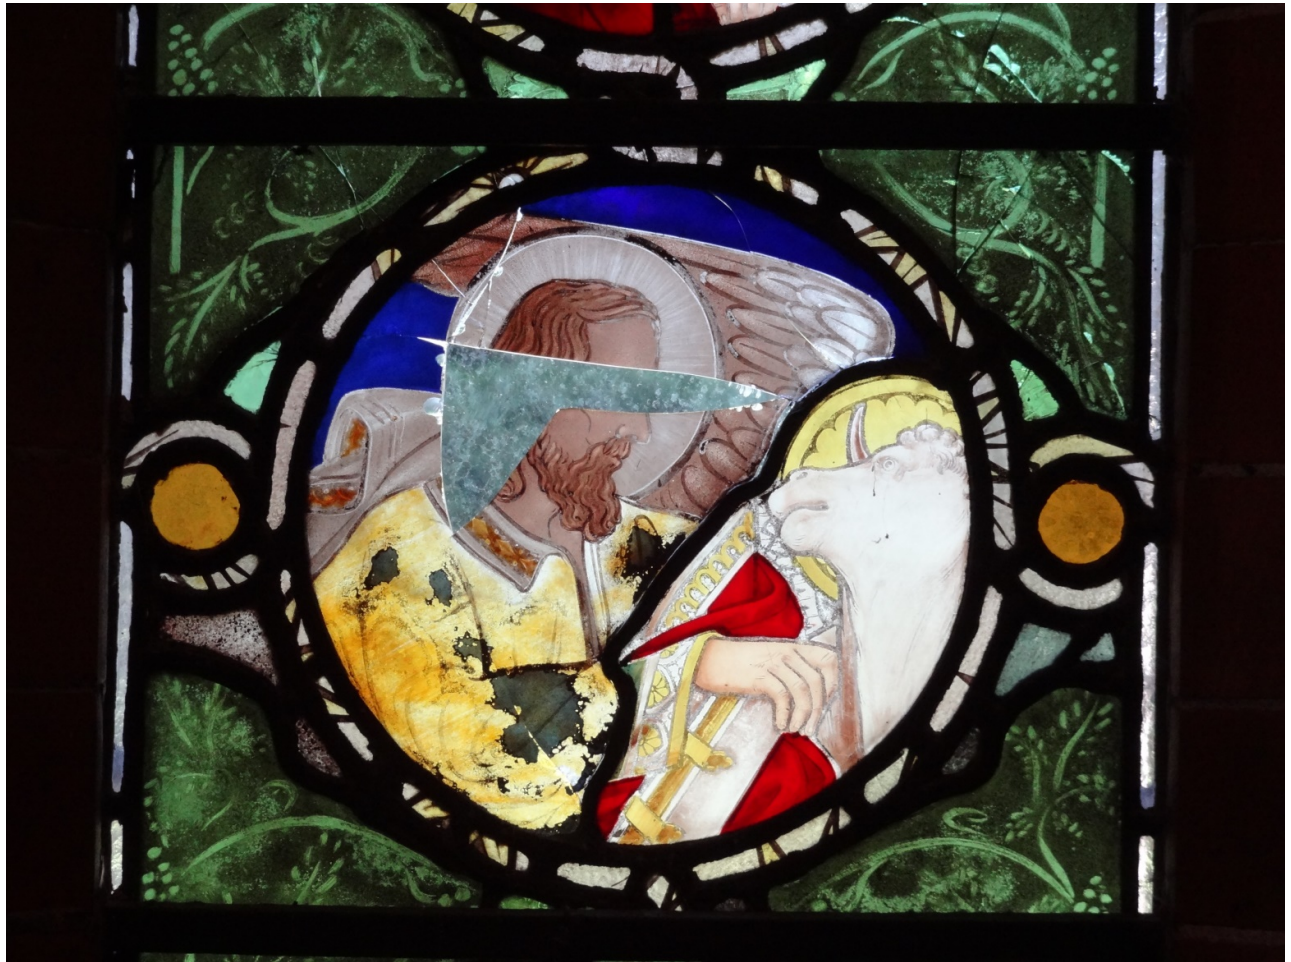
For the central window the force of the blow was sufficient to damage the glass, critically breaking it across the face of one of the figures portrayed. The polycarbonate protection shows the mark of the impact.

Damaged Section

Carefully removing the full stained glass window section from the stone surround, then to temporary glaze the opening using timber boarding.

Bringing the stained glass window back to our studio for restoration work as found necessary, comprising of taking detailed rubbings of the damaged section, setting out working drawings, carefully dismantling the damaged section noting the position of each piece of broken stained glass. Then part remaking the damaged section with new lead came re-using as much of the existing glass as possible, the large face detailed piece and other detailed painted pieces of glass will be replaced, each hand painted then fired on tinted antique glass to match existing as near as possible.

Re-installing the restored stained glass window back into position fixed with new none ferrous metal stay bars painted black and copper tie wires where applicable, then sealing with a narrow, slightly chamfered lime mortar pointing on both sides.

Finally replacing the badly scratched 6mm polycarbonate with new.

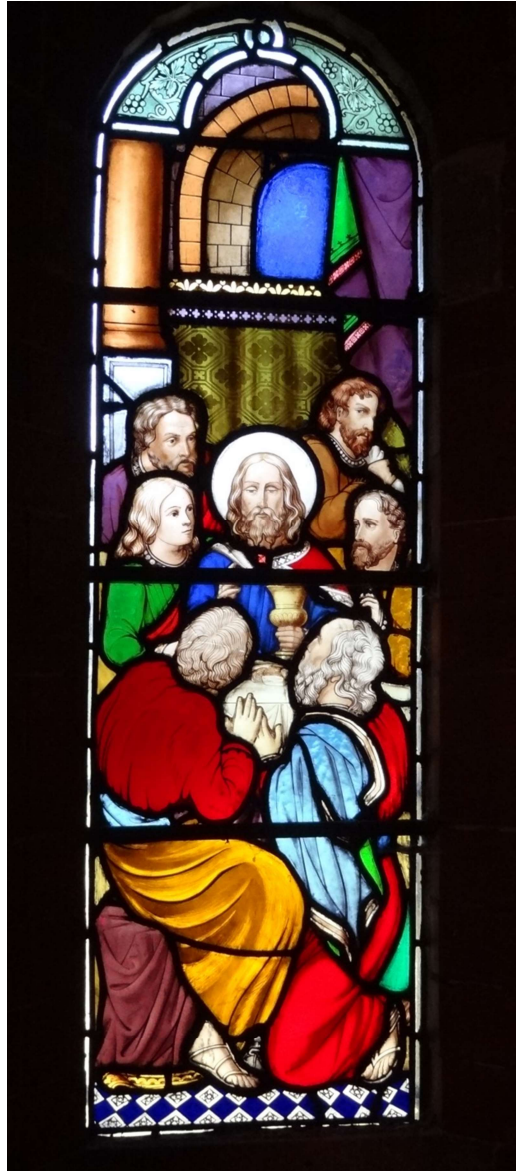
Right hand (North) Window

Full Window

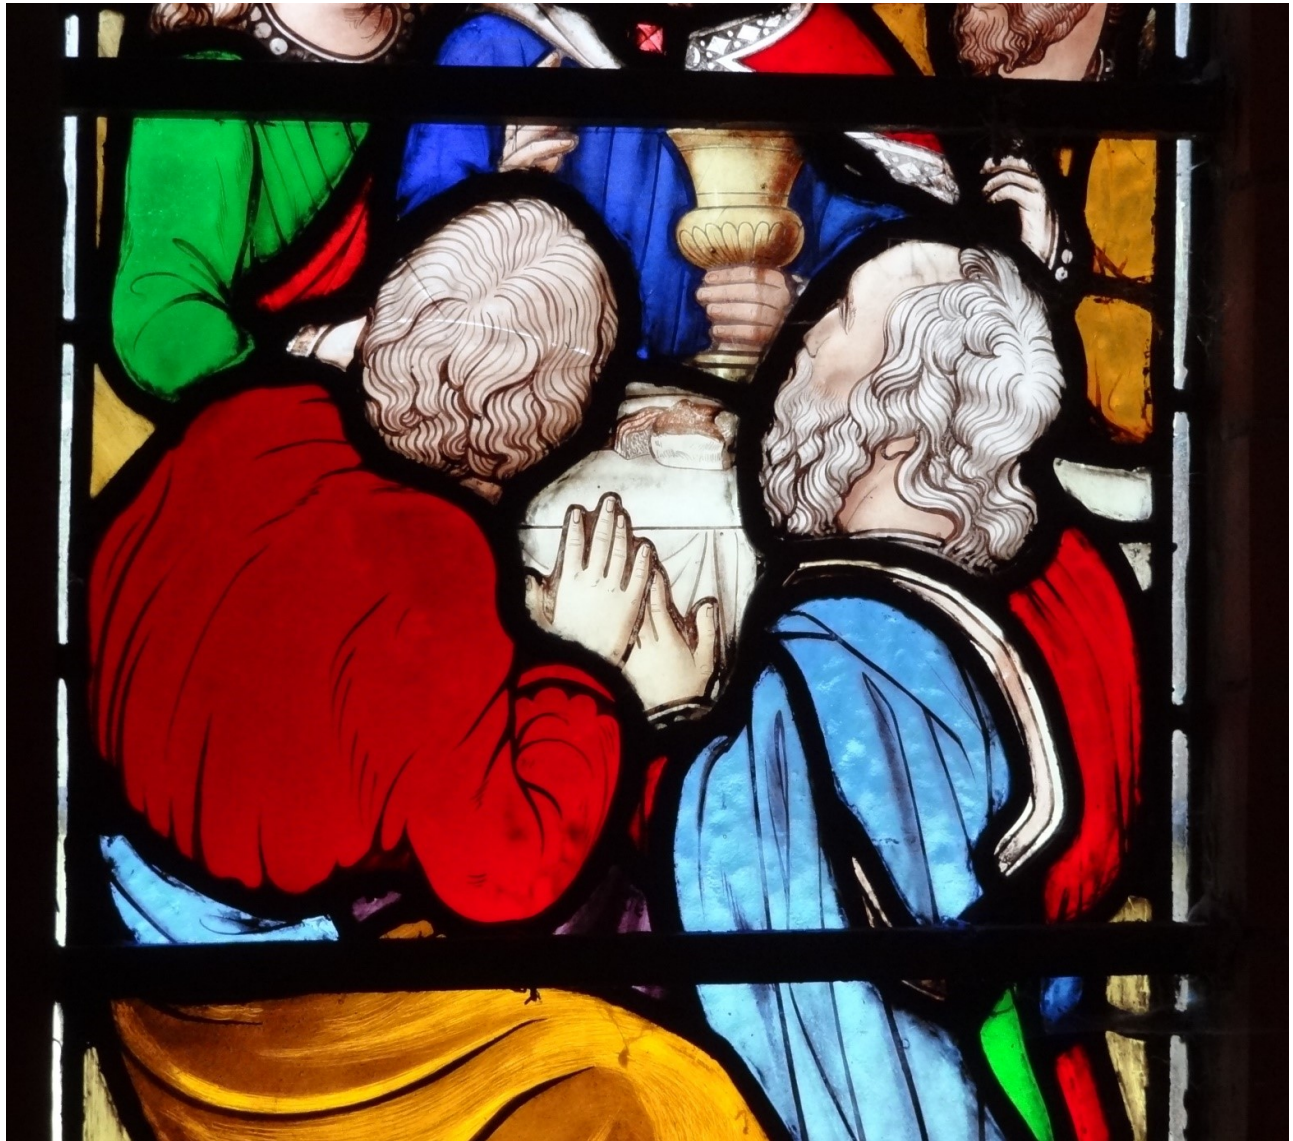
The window on the right (as seen from inside the porch) was attacked also, and resulted in a hairline crack, visible on close inspection. Attempting a repair would spoil the window. The glass is otherwise sound, and both contractors recommend leaving well alone.

Impact Section
