Christleton St James – Tree removal

STATEMENT OF NEEDS FOR FACULTY APPLICATION TO FELL TREES IN CHURCHYARD OF ST. JAMES' CHURCH CHRISTLETON

TREE CONDITION ASSESSMENT

Tree Condition Assessment: St James’s Church, Village Rd, Christleton, Chester, CH3 7AJ **Date:** 18/03/22 **Weather:** Dry **Surveyor:** PM

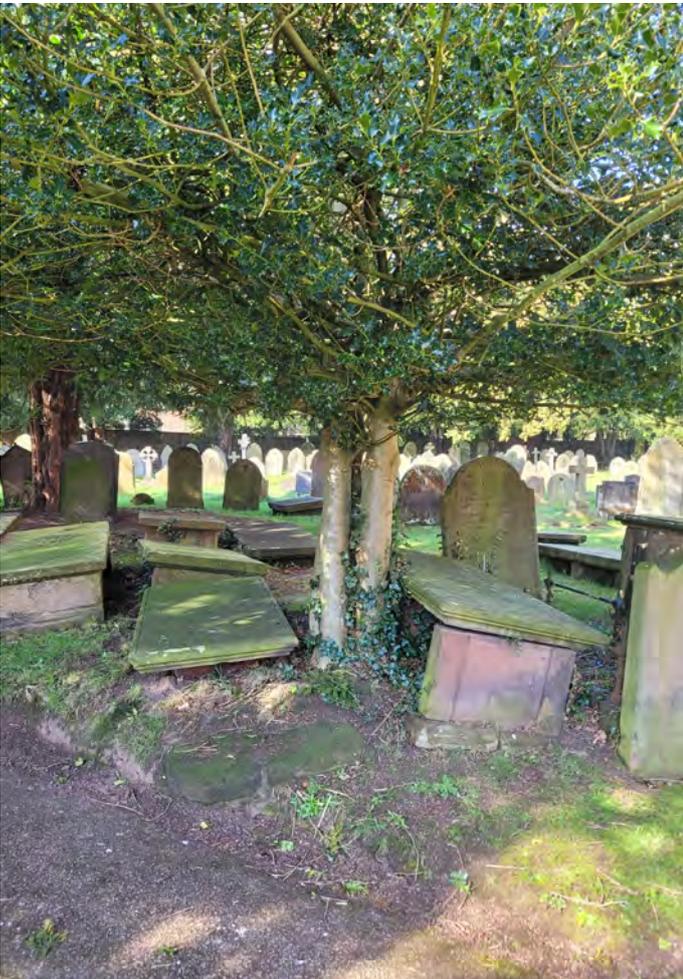
T3

<p>T3 Holly is nearly dying (Condition B/C), but the diameter of stems at 1.5m above ground level are probably less than 75mm from the photo, which would allow removal under List A</p> <p>T17 Hawthorn is dying (Condition C) so can be removed under List B</p> <p>All the other work is OK under List B</p>
<p>06/05/2022</p> <p>To: Katy Purvis From: Bettie Gilliatt</p>	<p>Just something more to keep me super-busy!</p> <p>There is too much work overall to tackle at the same time not to speak of cost so we shall have to phase pruning as necessary.</p> <p>The cypresses need to be removed before we can tackle the paths.</p> <p>I future if anyone wants to plant tree we shall ask for donation of £100,000 to look after it during its life!</p>
<p>09/05/2022</p> <p>To: Bettie Gilliatt From: Katy Purvis</p>	<p>List B approval doesn't have a time limit, so if you apply for that work you would still have permission after the faculty is sorted for the cypresses, so it is still worth sorting that part out, even if you don't do all of it at once.</p> <p>Yes, trees can be expensive to look after! Walls are worse though, we shouldn't ever let anyone build a wall!</p>

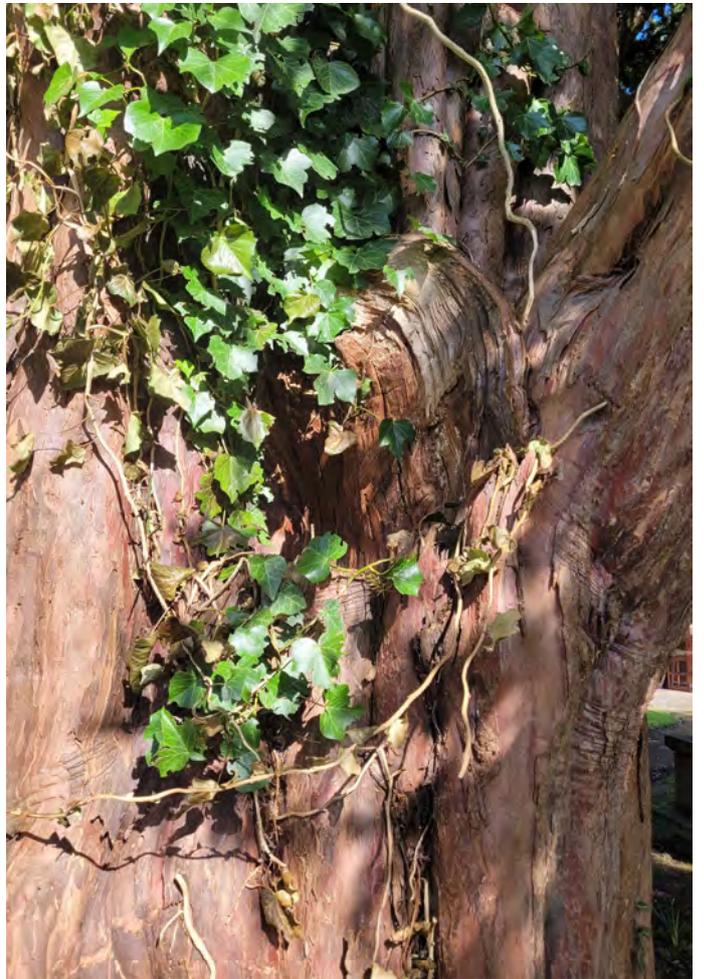
T5	Yew	6-10	M	A/B	An individual specimen with typical multi-stemmed form and a spreading crown. Previous failure within the fork but the wound doesn’t appear decayed, and a resonance test also provided no signs of decay. Stem shoots regularly pruned. Minor low branches over graves. Reasonable form and vigour, slight unbalanced due to limb failure.	Light crown lift to approximately 2m.	3
T6	Yew	6-10	M	A	An individual specimen forked near base with a spreading crown. Previous removal of lower branches. Stem swamped in Ivy. Good form and vigour.	Sever Ivy at base to 1m.	3
T7	Irish Yew	6-10	EM	A	Located adjacent within raised planting area exhibiting good form and vigour.	n/a	-

T5 limb failure

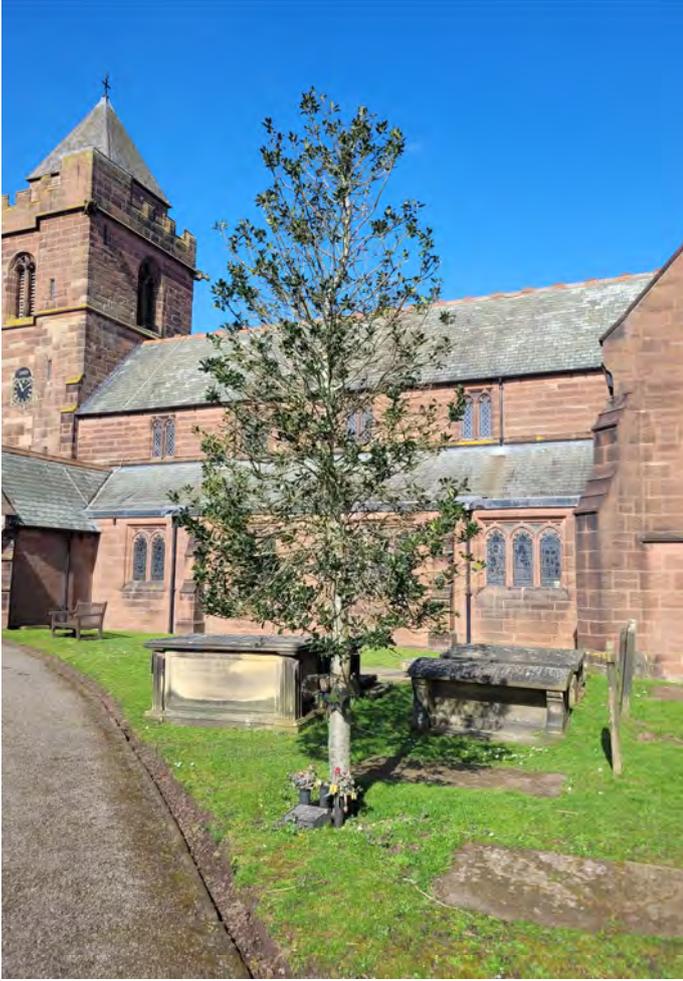
T9 sparse crown

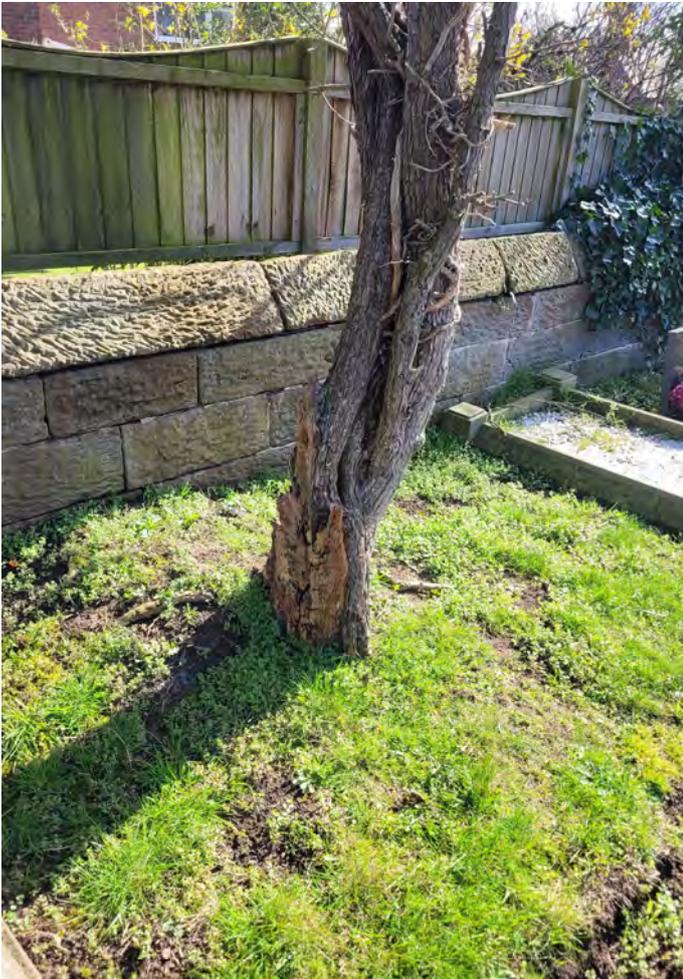
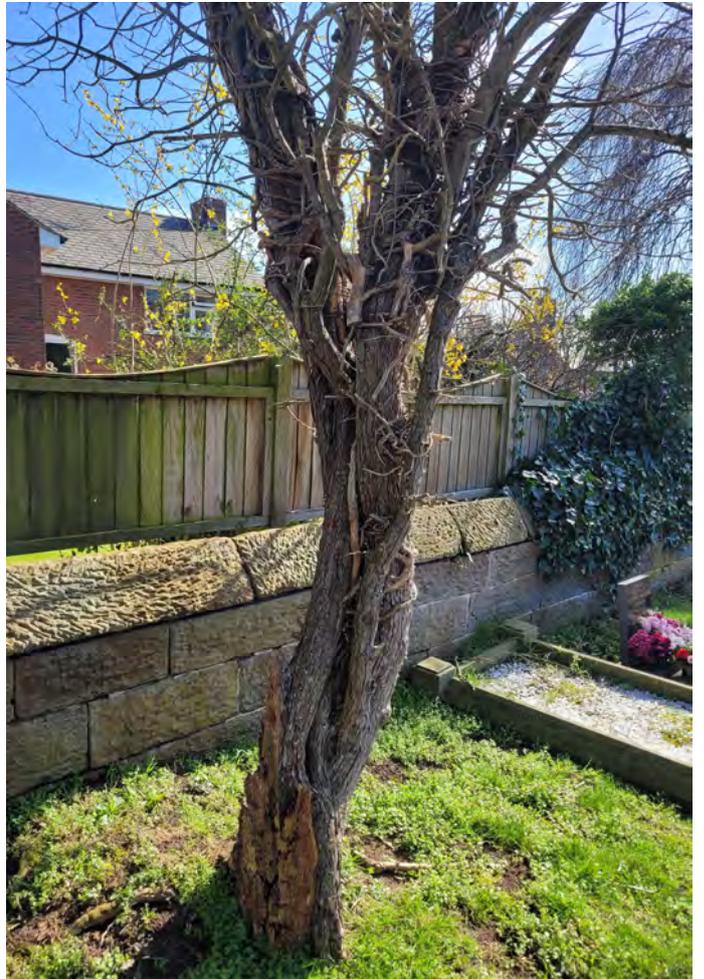
Tree Condition Assessment: St James’s Church, Village Rd, Christleton, Chester, CH3 7AJ								Date: 18/03/22	Weather: Dry	Surveyor: PM
Tree No.	Species	Height (m)	Age	Condition Rating	Comments	Recommendations	Priority Rating			
T17	Hawthorn	0-5	M	C	Previous loss of secondary stem at base, wound significantly decayed. High likelihood of failure.	Fell to ground level.	3			
OS2	Group – 3 Silver Maple	11-15	M	B	Located within the adjacent site. High crowns from previous pruning and evidence of previous reduction works within the crown. One stem is heavily swamped in Ivy.	Sever Ivy at base to 1m.	3			
T18	Lawson Cypress	6-10	FM	B	A mature Coniferous tree previously topped with a spreading crown. Exhibits good vigour but is considered to have outgrown its location. The roots are causing major disturbance to the paths and edging stones, which would be difficult to practically repair with the trees in place.	Fell to ground level.	2

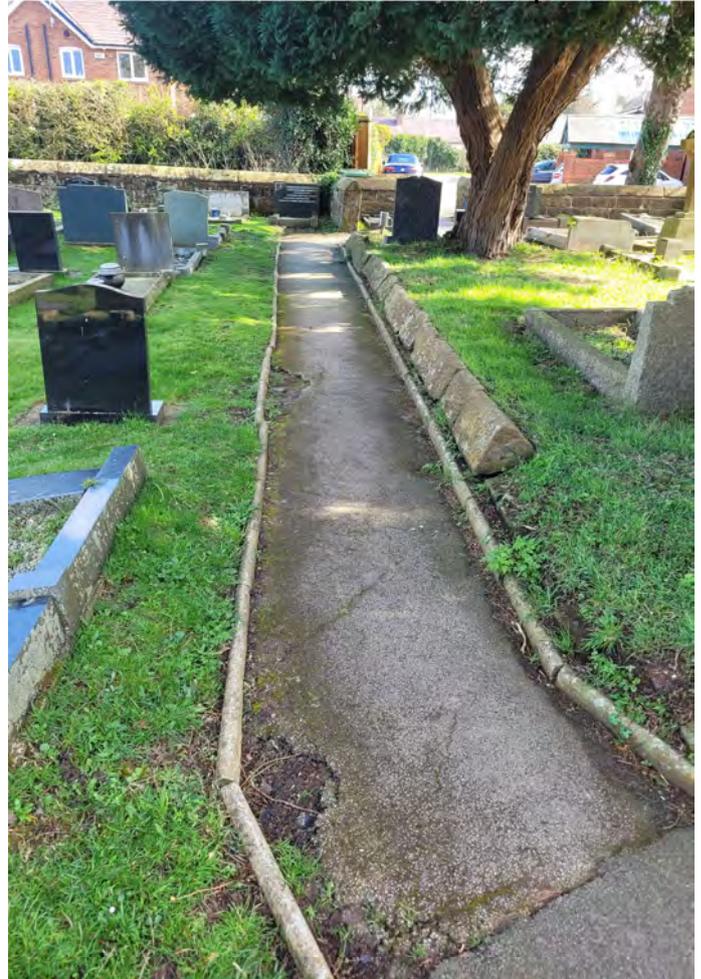
When the two Lawson cypress trees are felled, the coping stones at the side of the footpath can be reinstated as they have been pushed out of alignment by the trees and their roots. The adjoining footpath has been distorted and potholed making it dangerous particularly in bad light. To anyone of reduced mobility it is extremely hazardous and impassable for wheelchairs. Additionally it is a tripping hazard for coffin bearers.

T18 root disturbance

Root disturbance to path

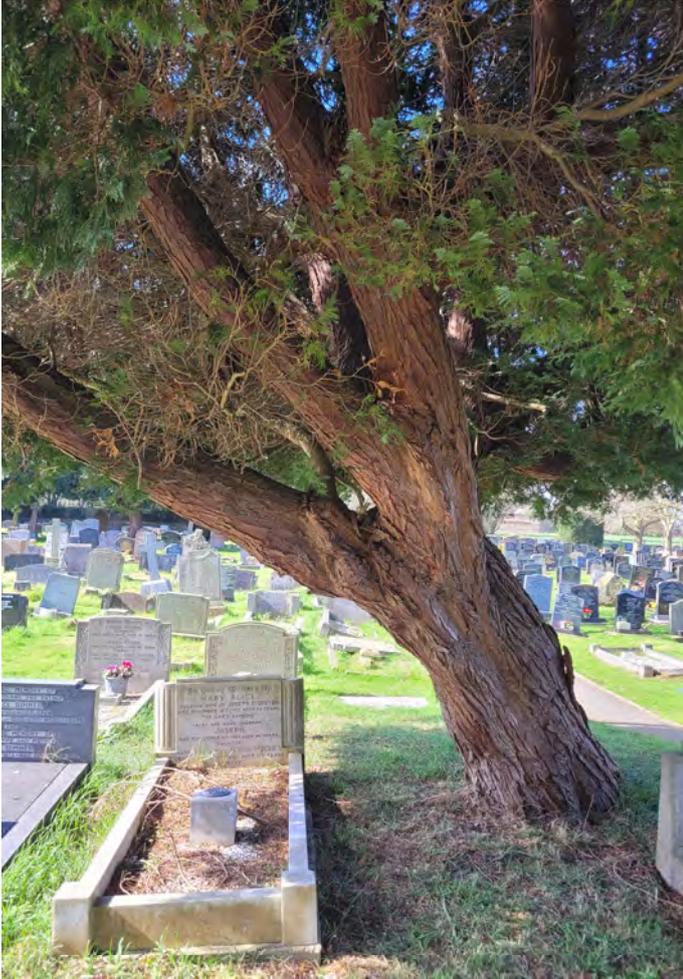
T19	Lawson Cypress	6-10	FM	B	A mature Coniferous tree previously topped with a spreading crown and leaning stem. Exhibits good vigour but is considered to have outgrown its location. The roots are causing major disturbance to the paths and edging stones, which would be difficult to practically repair with the trees in place.	Fell to ground level.	2			
T20	Hawthorn	0-5	M	B	An individual specimen with reasonable form and vigour. Minor wounds with associated decay.	n/a	-			
T21	Field Maple	6-10	M	B	Located on the boundary with spreading form and good vigour. Large surface roots present. However, there are two lower branches that have been damaged and will eventually fail.	Remove two lower damaged branches.	3			
T22	Japanese Cherry	0-5	EM	B	Located on the northern boundary. Exhibits major crown asymmetry and the stem is swamped in Ivy.	Sever Ivy at base to 1m.	3			
T23	Japanese Cherry	0-5	Y	B	A young specimen located on the northern boundary still at the stake.	n/a	-

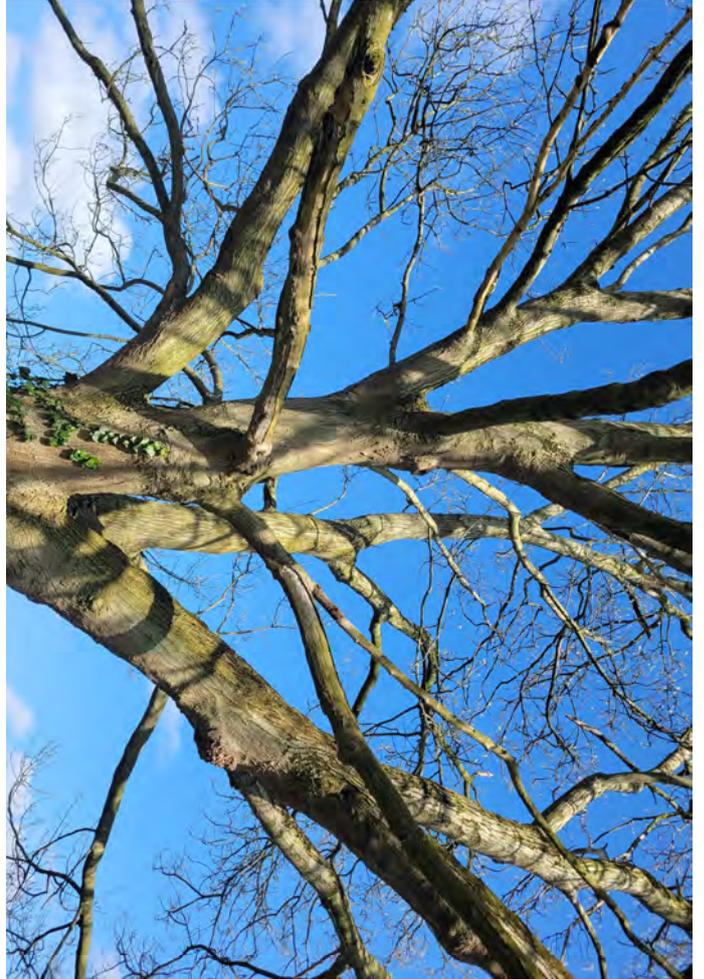
T20 damaged lower limbs

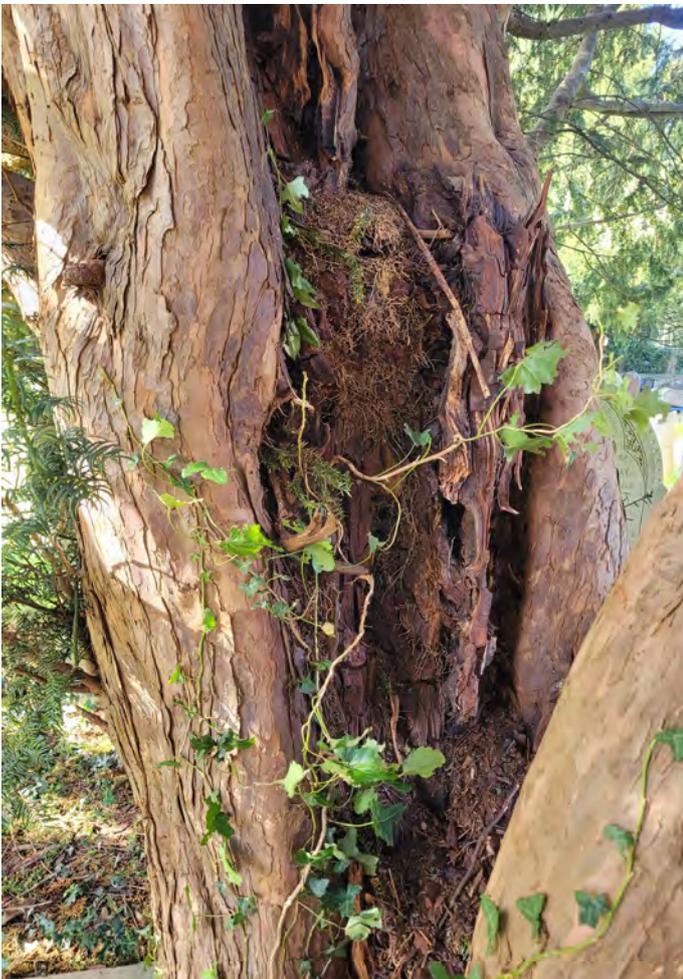
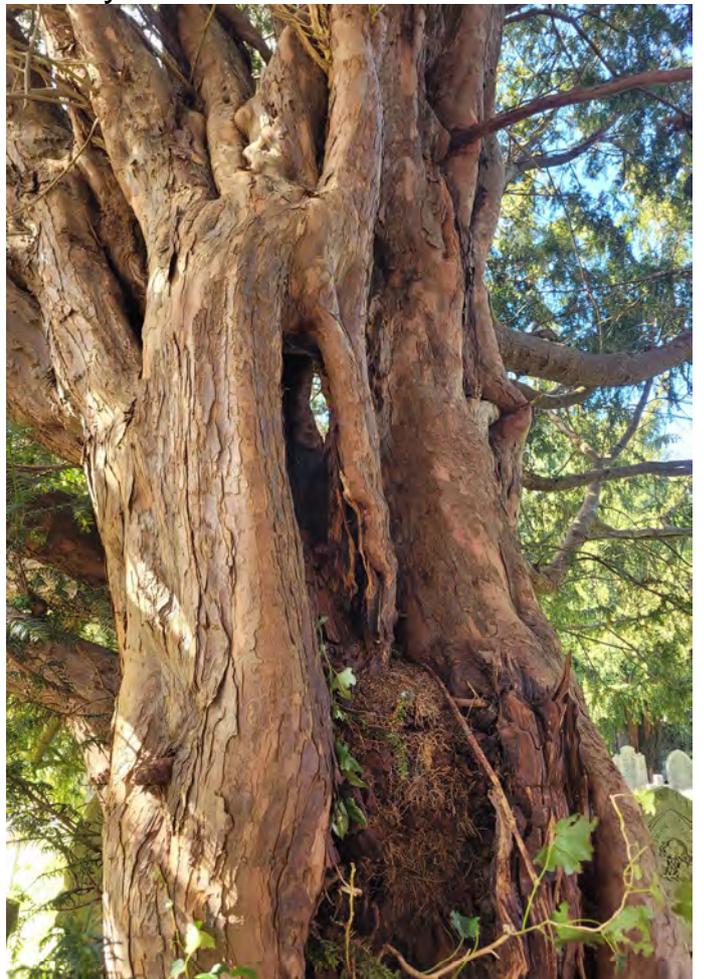
T42 stem decay

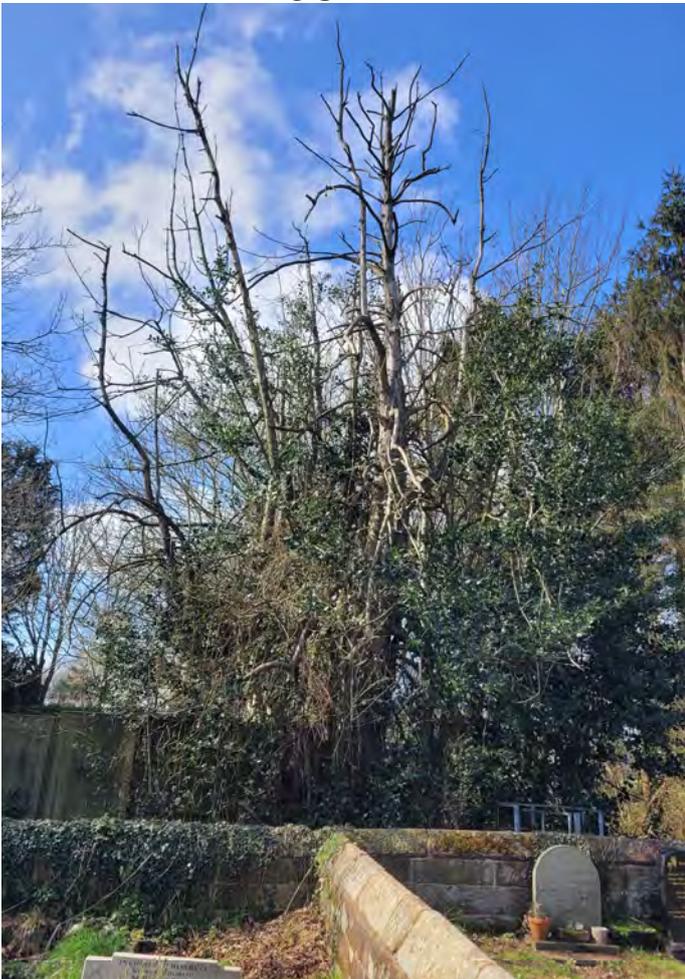
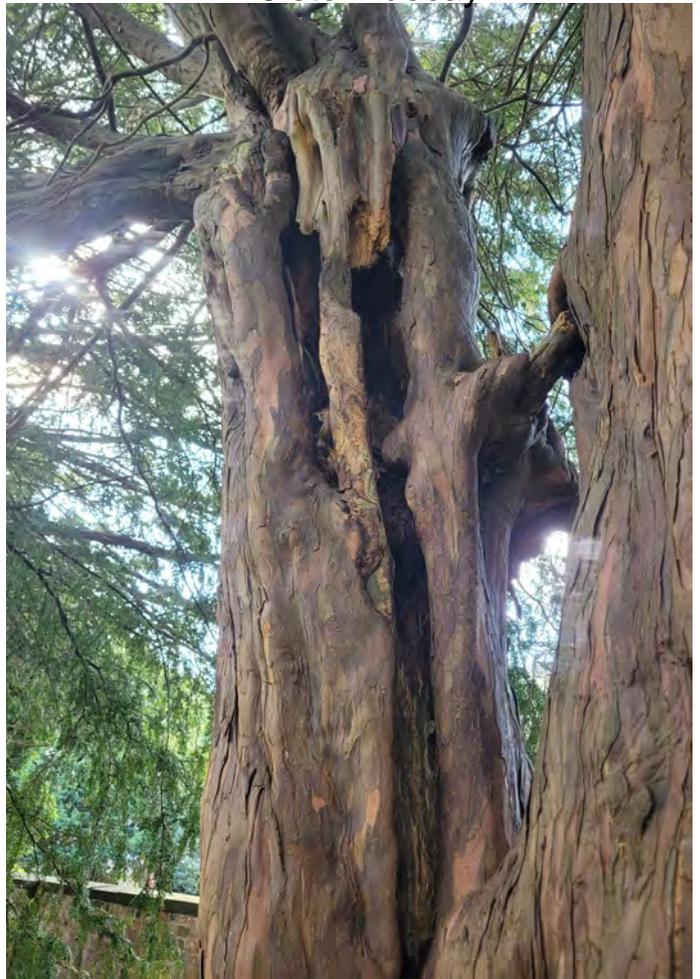
T47	Variegated Holly	6-10	EM	B	Located within linear group with major crown asymmetry over footpath due to suppression.	n/a	-			
T48	Yew	6-10	M	B/C	A co-dominant specimen within linear group to the rear of low retaining wall adjacent to footpath. Forked at 1.5m forming two co-dominant stems, the southern stem is severely decayed, which could be due to historic topping operations. This stem is liable to collapse.	Reduce and re-shape whole crown by approximately 2m.	2			
T49	Yew	6-10	M	A/B	A co-dominant specimen within linear group to the rear of low retaining wall adjacent to footpath. Exhibits reasonable form and vigour. Previous removal of lower branches, high crown. Minor disturbance to low retaining wall. Possible historic topping operations.	n/a	-

T48 stem decay
