# Supporting Documentation

## Sutton St James – Window repairs

# Statement of Significance

Report on the Condition of the Glazing.

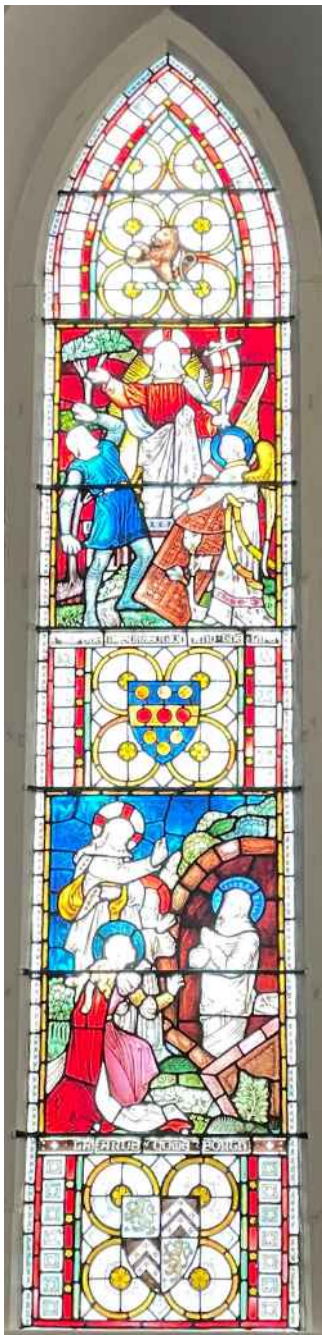
Image from inside the church

The stained glass window appears to be in a varying condition throughout its length and there is evidence of bowing and bulging, cracked quarries, fractures to lead comes, along with paint loss across the window. The window itself consists of 5 individual sections which sit on top of each other glazed into a timber frame, the frame which shows evidence of previous repairs through cut and splicing. There are saddle bars installed internally for strength which appear to be in satisfactory condition with copper wire ties attached.

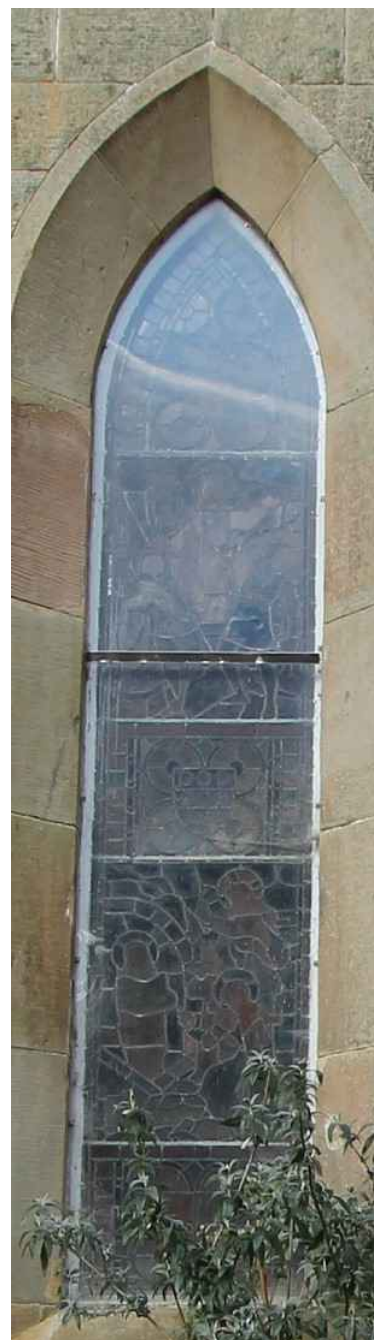
Image from outside

| c. | Defects: Externally there are fractures to the lead comes, primarily located on the lap lead that holds the panels together. | | |
