Altrincham St George – Window repairs

Repair of two Stained glass Windows damaged by vandalism

INITIAL OVERVIEW

ALTRINCHAM ST. GEORGE; Schedule of Work and Specification

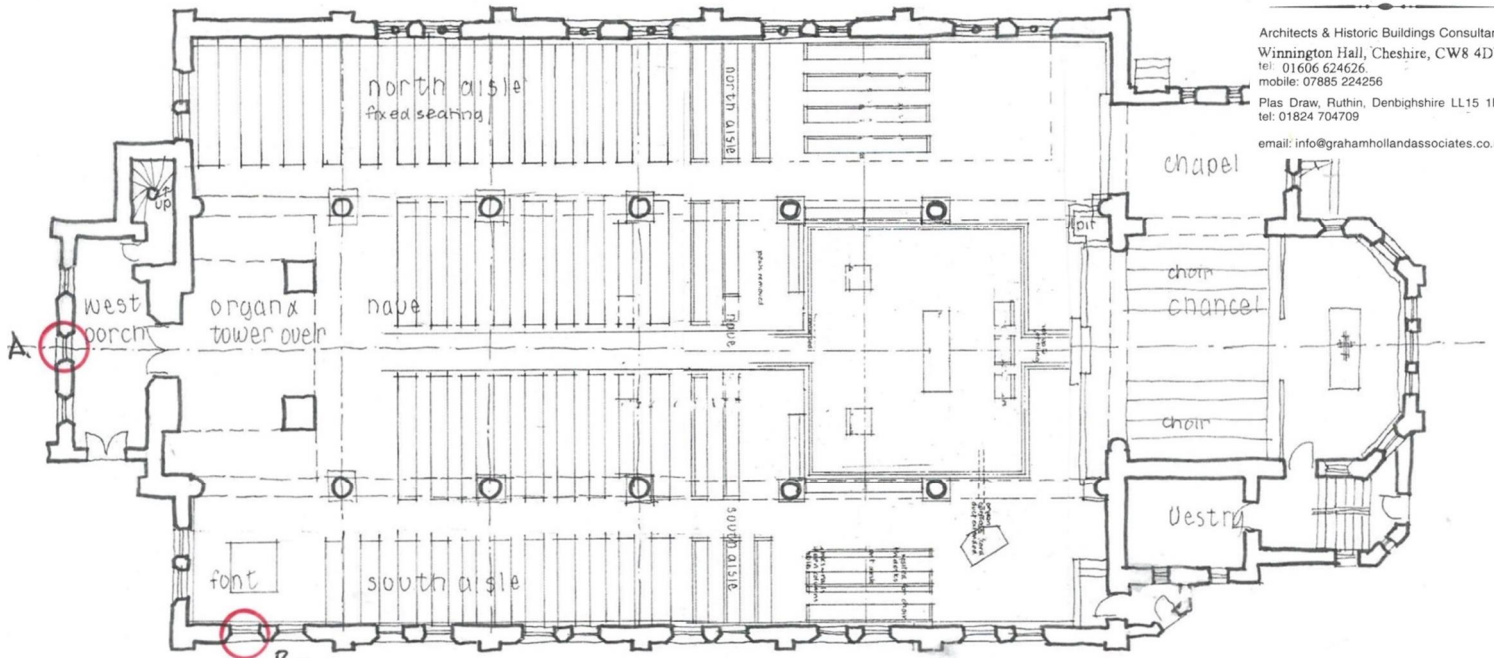
floor plan scale 1:100 @ A

The Project comprises repairing & releading the south aisle west window (single lancet), & west porch centre window.

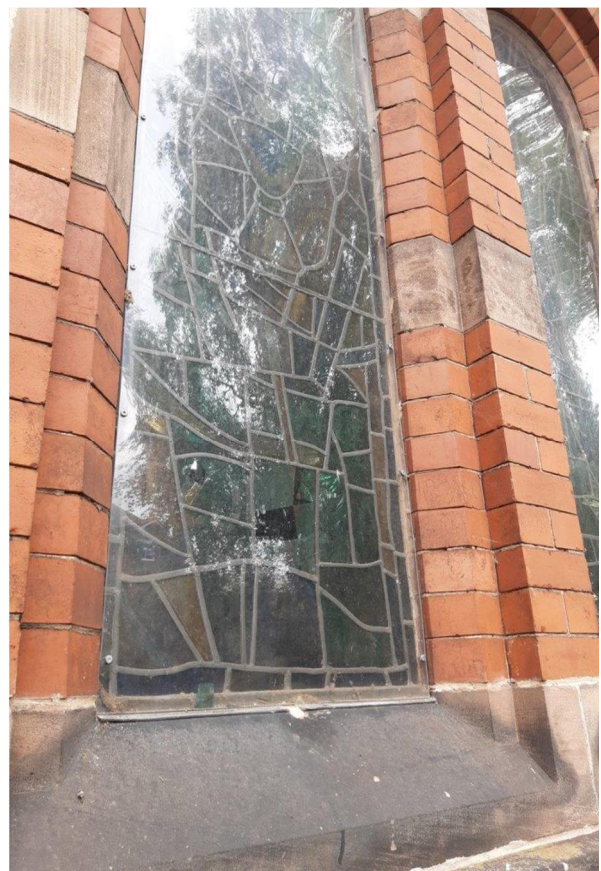
South aisle window, far west panel

Reasons for Work vandal damage.

K	Glazing	To the south aisle, west window 'B' , repairing & relaiding the panel.
	Access	As noted on the attached drawing & photograph.
L	Protection	Provide externally & internally as required.
M	Take out	Remove with care, the existing damaged panels of glazing complete and without further breakage or damage to the window glass or framework; clean off mortar and bedding
O	Artist	Liaise with original stained glass artist- Andrew Taylor to repair the breakages, replacing etched and painted glass where necessary and using HXTAL NYL-1 epoxy bonding resin and cosmetic lead etc., as might be best applicable to some of the breakage.
P	Board-up	Provide & fix secure and weatherproof boarding to the windows or temporarily re-glaze immediately after removal of glazing; remove on re-glazing.
Q	Relead	Original -artist to provide new lead comes to match the existing and relaid the glass complete, in panels as existing.

R	Repairs	Provide make-up glass to match, copying exactly in style, texture, thickness & colouring.

We recommend using the original artist for the south aisle window repair, with Lightfoots taking out and transporting the damaged panel to Worcester.
