Christleton St James – Tree removal

STATEMENT OF NEEDS FOR FACULTY APPLICATION TO FELL TREES IN CHURCHYARD OF ST. JAMES' CHURCH CHRISTLETON

TREE CONDITION ASSESSMENT

Tree Condition Assessment: St James’s Church, Village Rd, Christleton, Chester, CH3 7AJ **Date:** 18/03/22 **Weather:** Dry **Surveyor:** PM

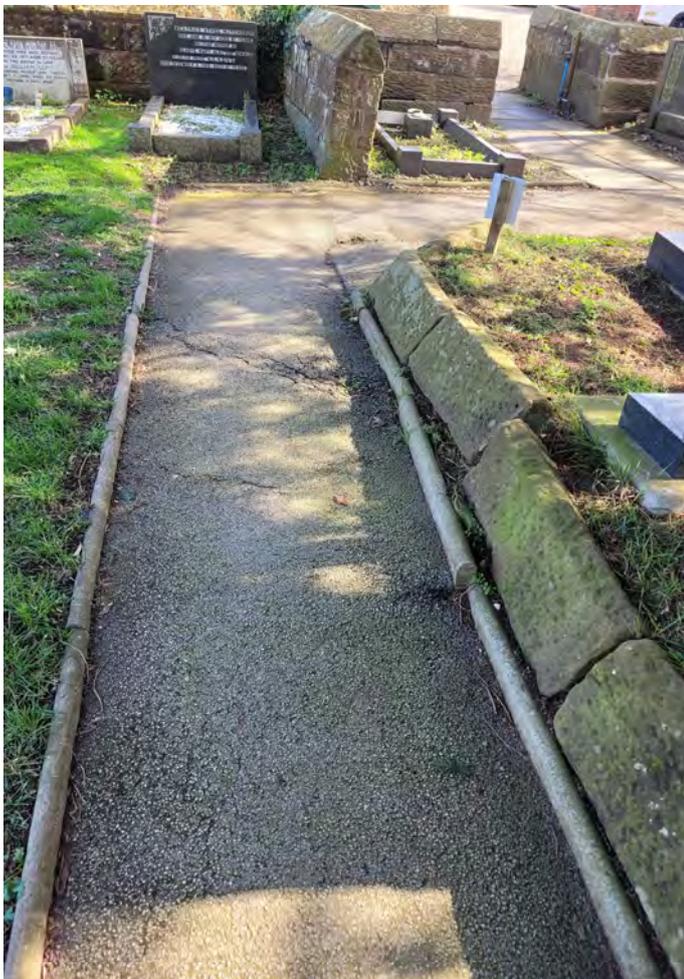
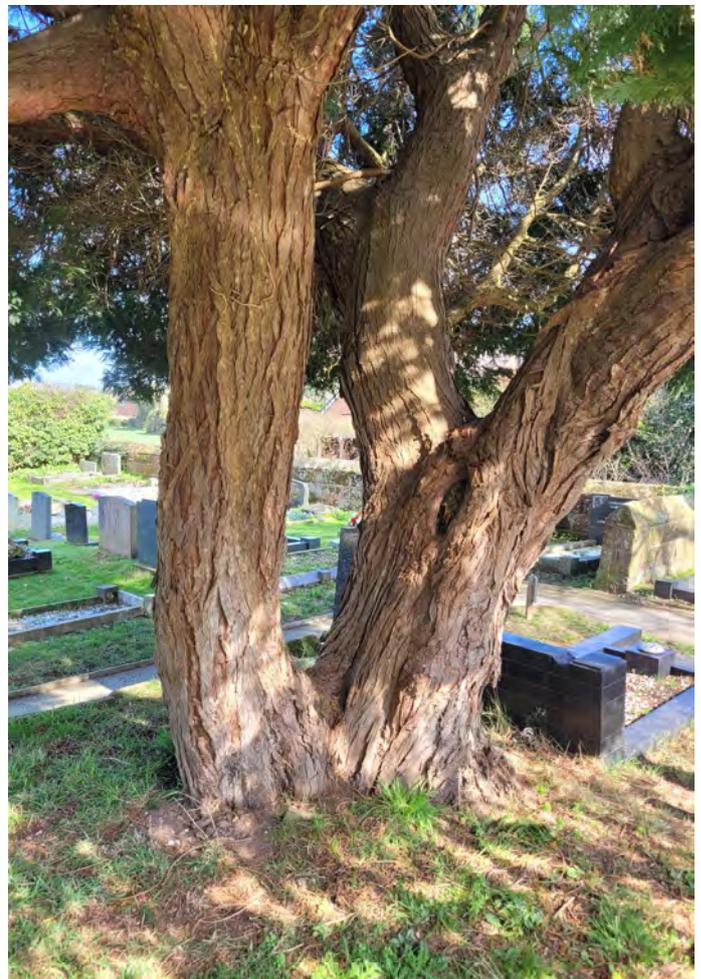
T18

Felling of two Lawson cypress trees which have caused and continue to cause damage to the main path to the currently used burial areas. The path and adjoining graves have suffered upheaval as the trees are too close. The trees are near the end of their lives and have already been topped several times, one leans at an acute angle and the other's trunk is in three sections. The path is a hazard to people; those with reduced mobility are at risk, wheelchairs are impossible and coffin bearers constantly trip.

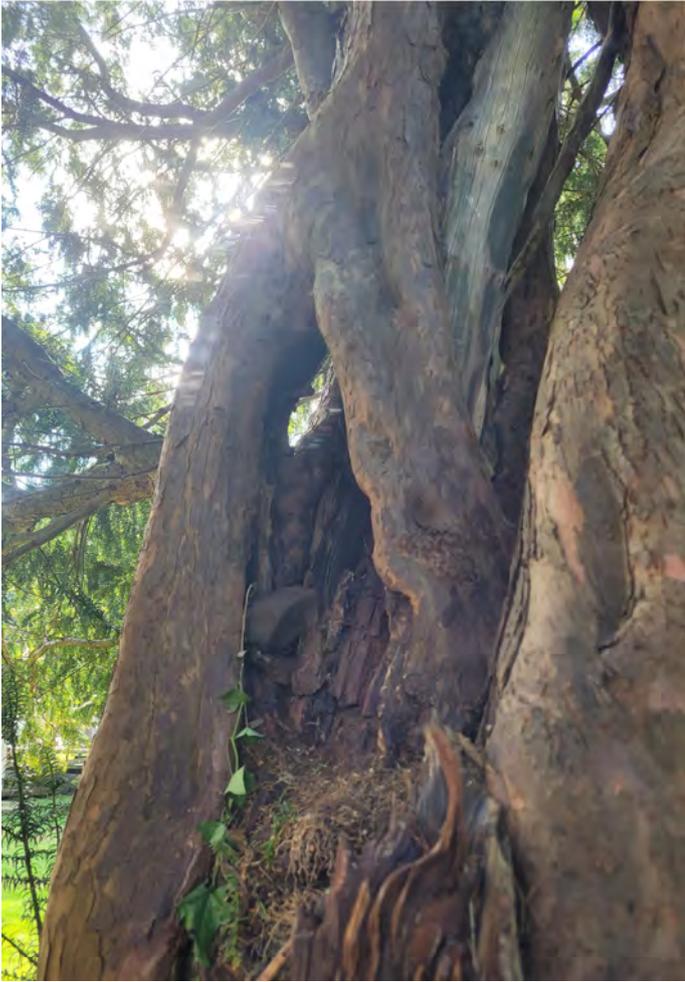
T42

- 2.2.1 In the main, the trees off the site were found to be in reasonable/typical condition for their age and species.
- 2.2.2 Several trees have been recommended for imminent works due to their potential for failure, which are T42, OS4 & T48 as detailed within the data of Appendix B and photographic evidence of Appendix D. In addition, although T18 & T19 are healthy specimens it is felt that they have now outgrown their location due to the impact that they are having on the footpath. Roots can be cut, and the tarmac can be repaired but it never lasts very long before roots return. They are old mature specimens of no major significance and can be replaced with smaller less vigorous species in an alternative location if necessary.
